**NYARUTARAMA**

**PROGRESS REPORT**  
**JULY AND AUGUST 2023**

## Phase 1.

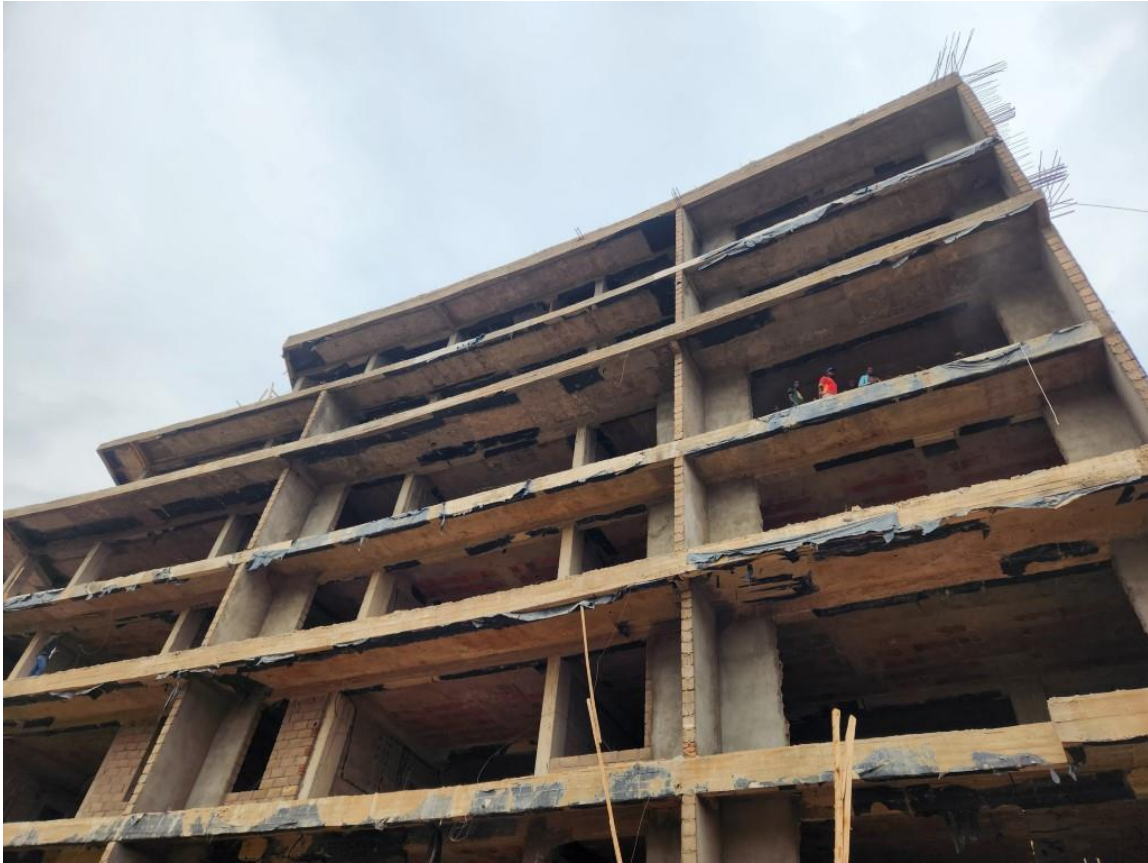
View from the ground floor

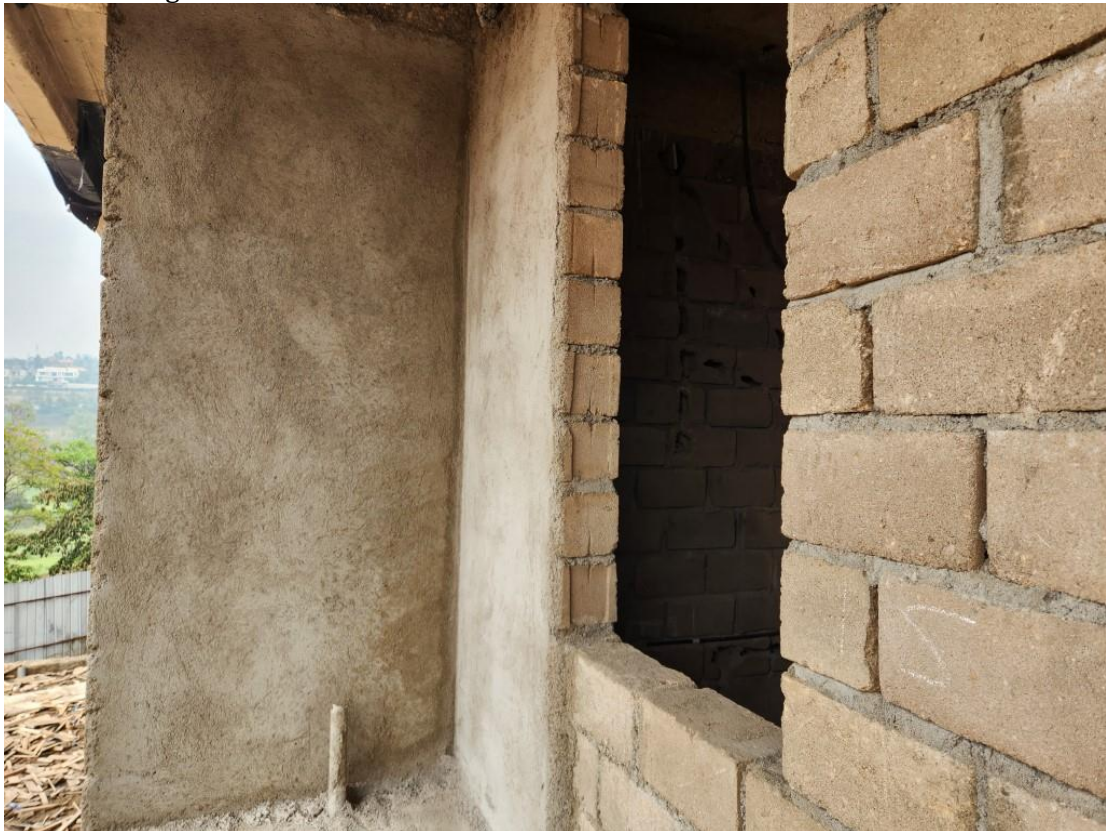
Walls separating the two units, plastering ongoing

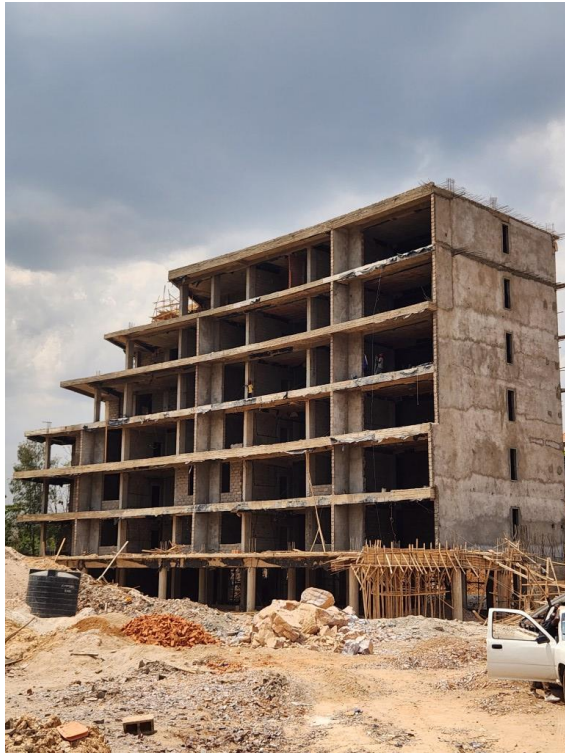
Front view

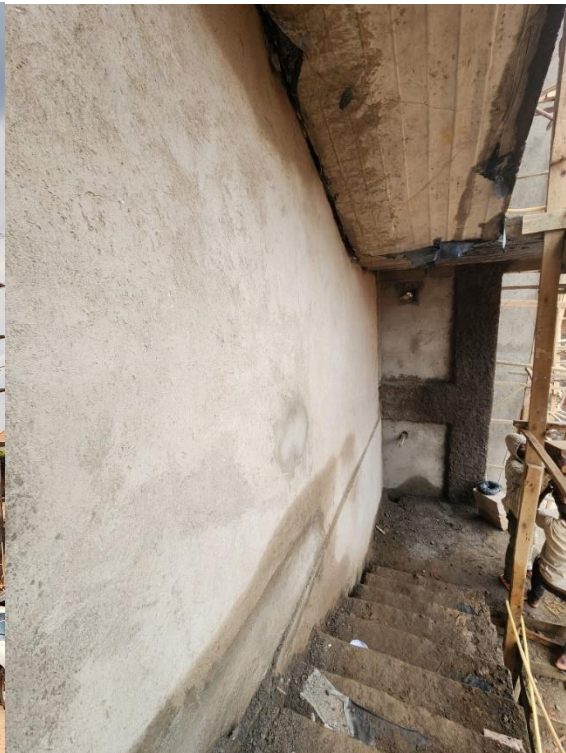
Staircase

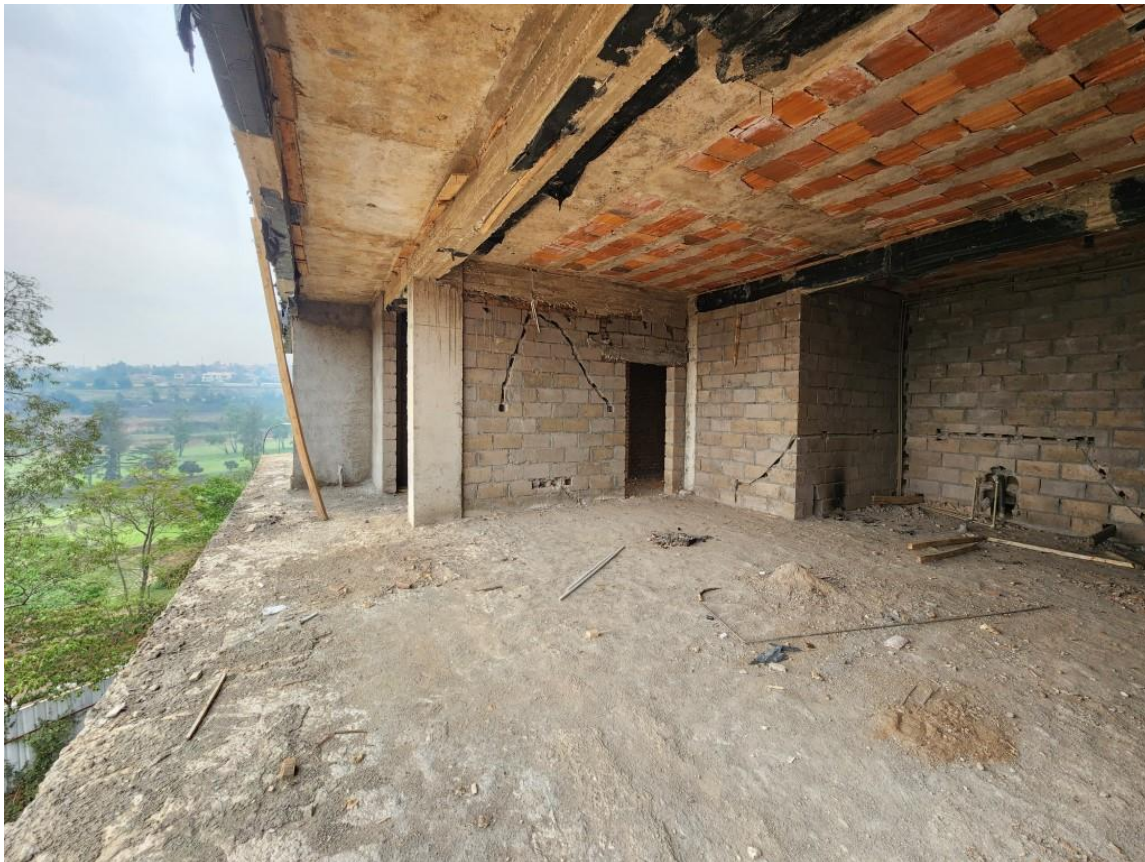
View of one of the apartments on the third floor, from the balcony

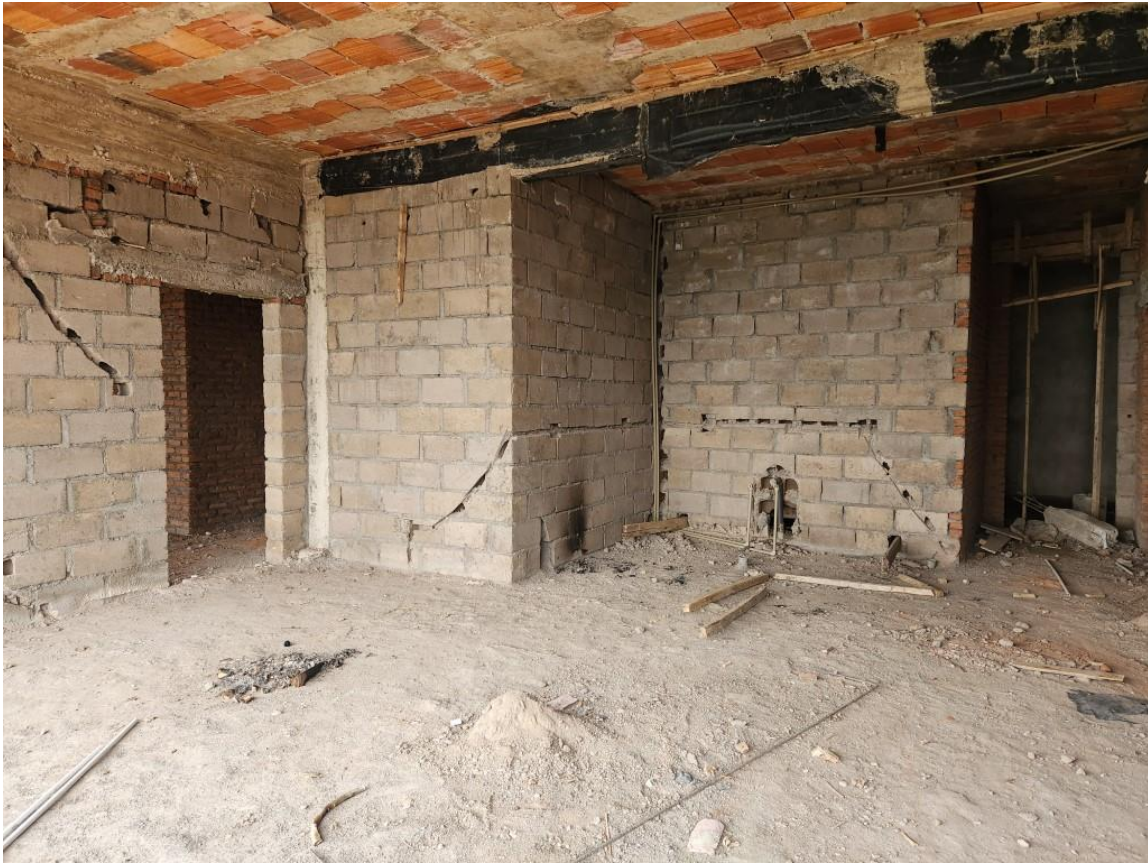
Open plan living, dining and kitchen area, showing the plumbing and electric ducts

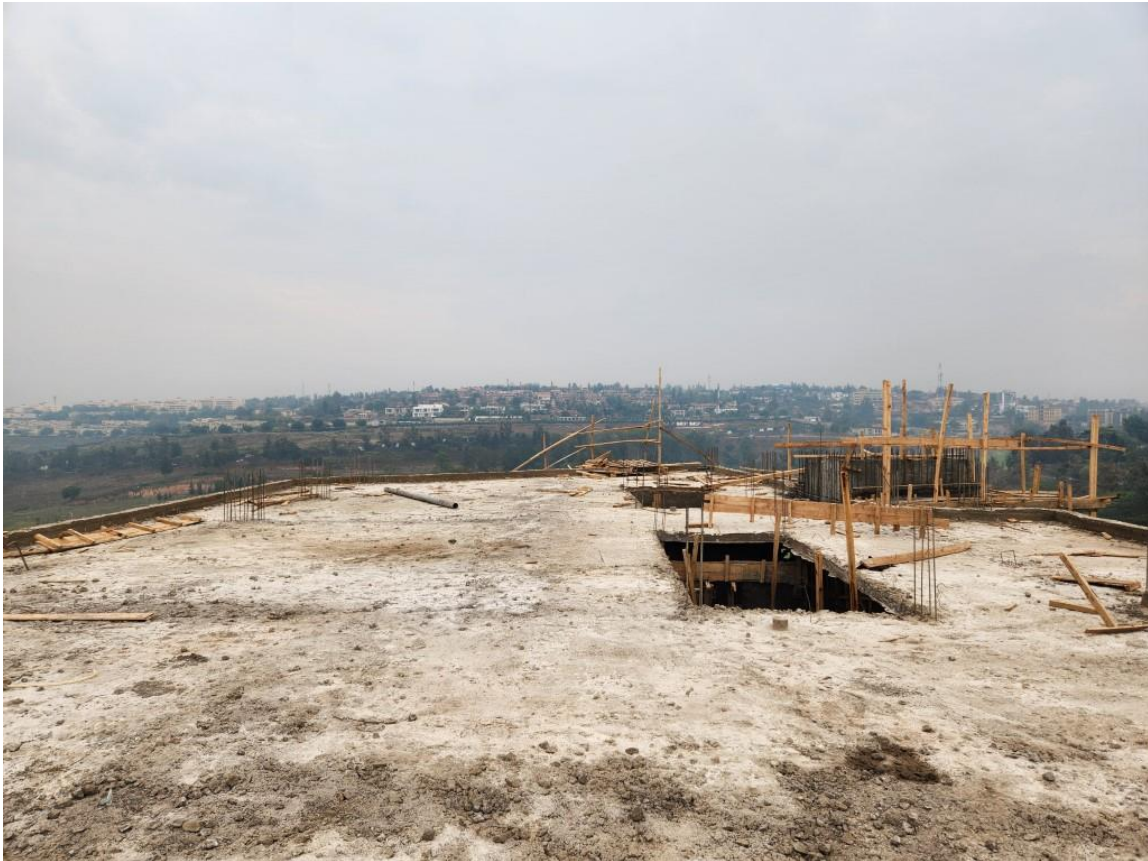
The roof slab, cast

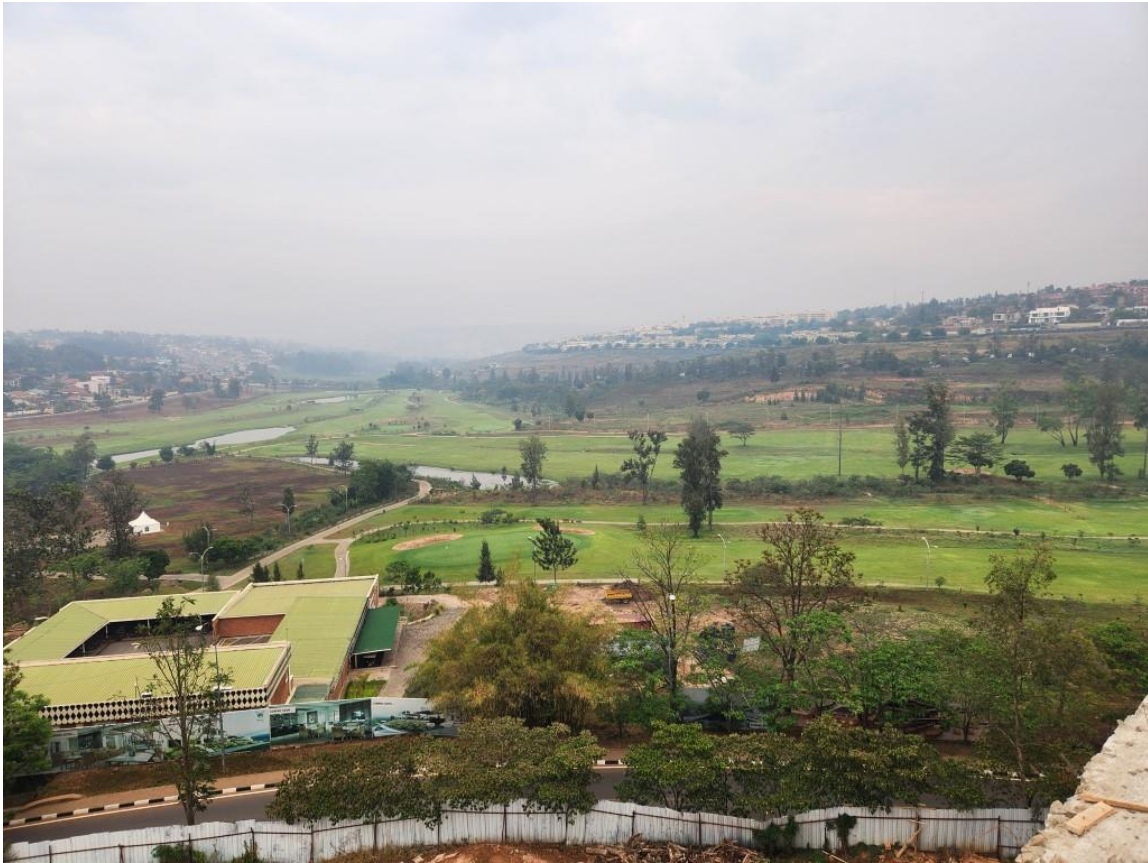
Views from the roof slab

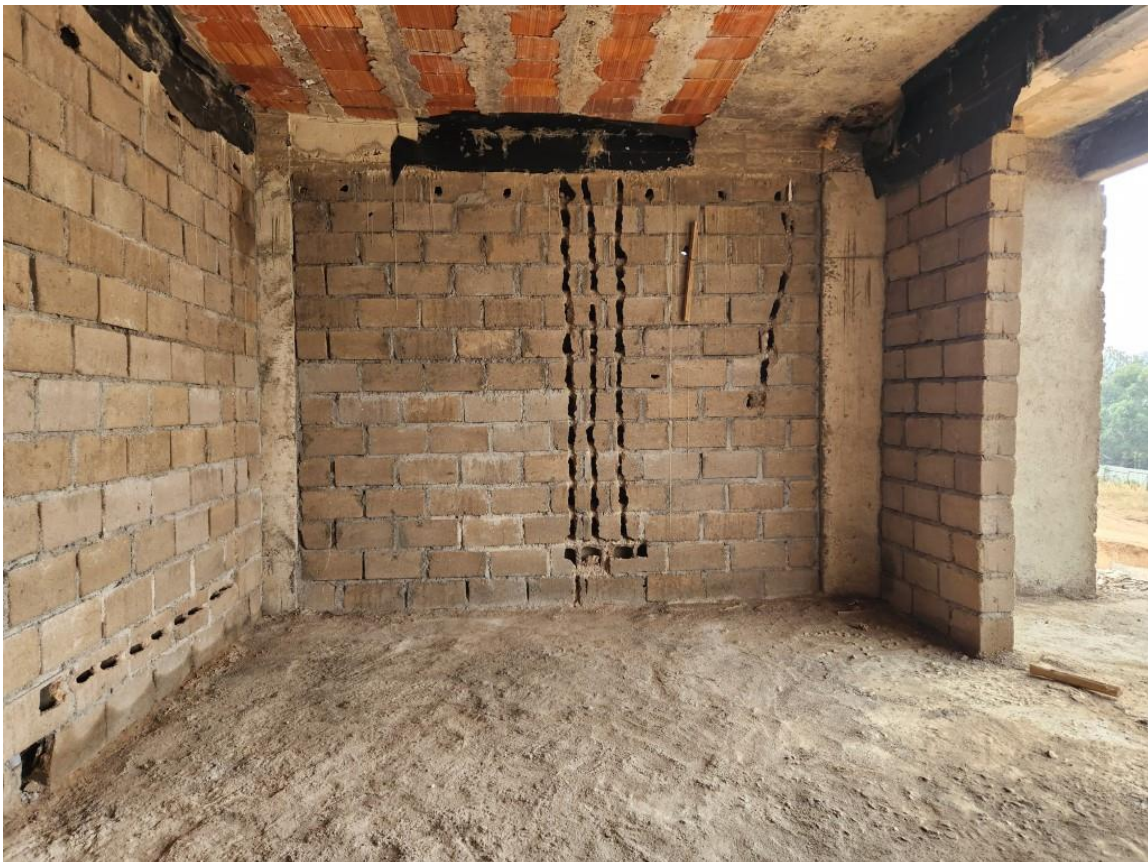
Electrical ducts in one of the apartments living area

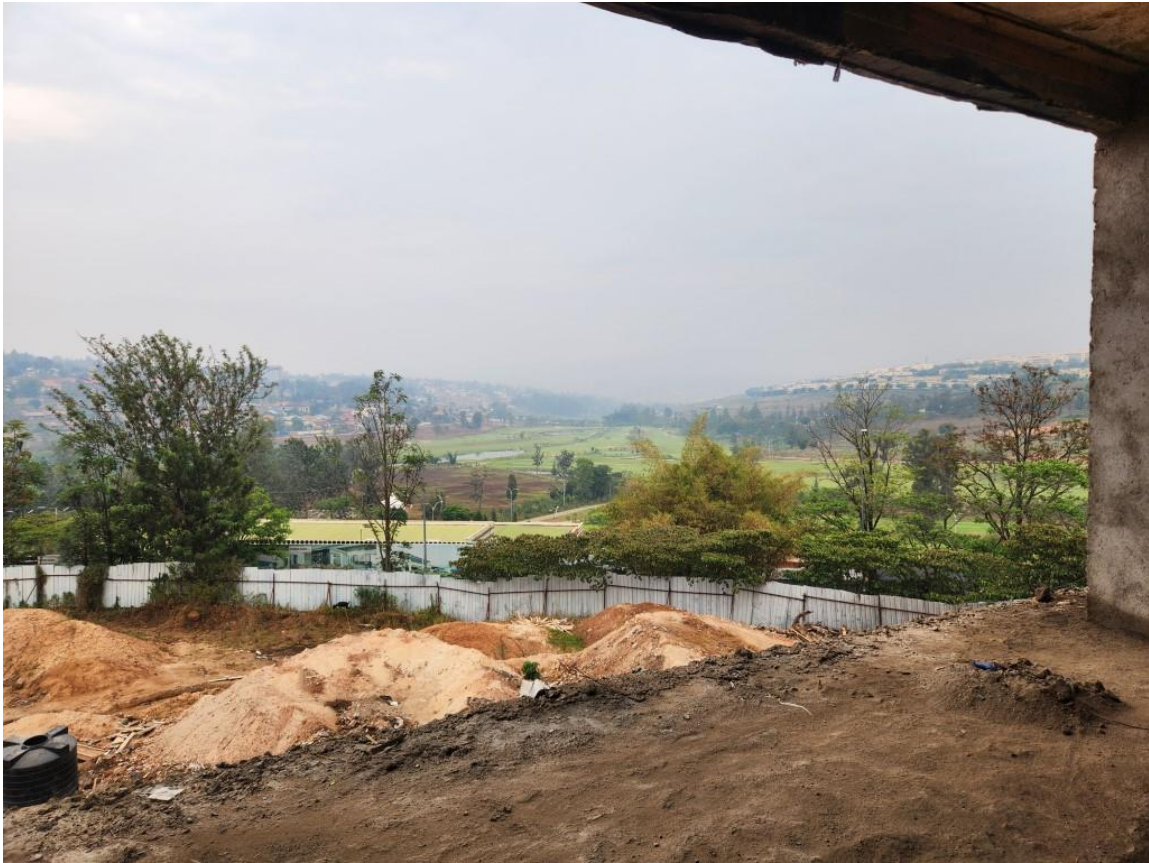
Views from inside one of the apartments on the first floor

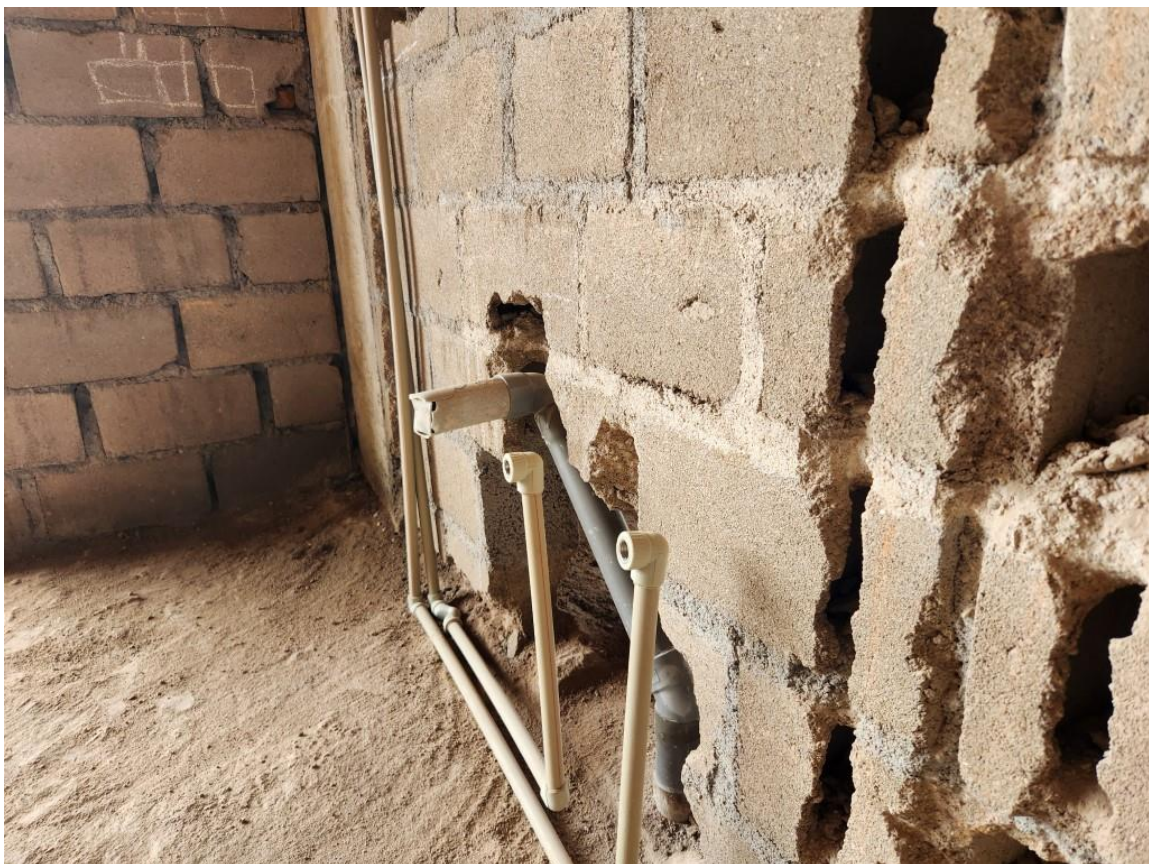
Plumbing works in the kitchen area

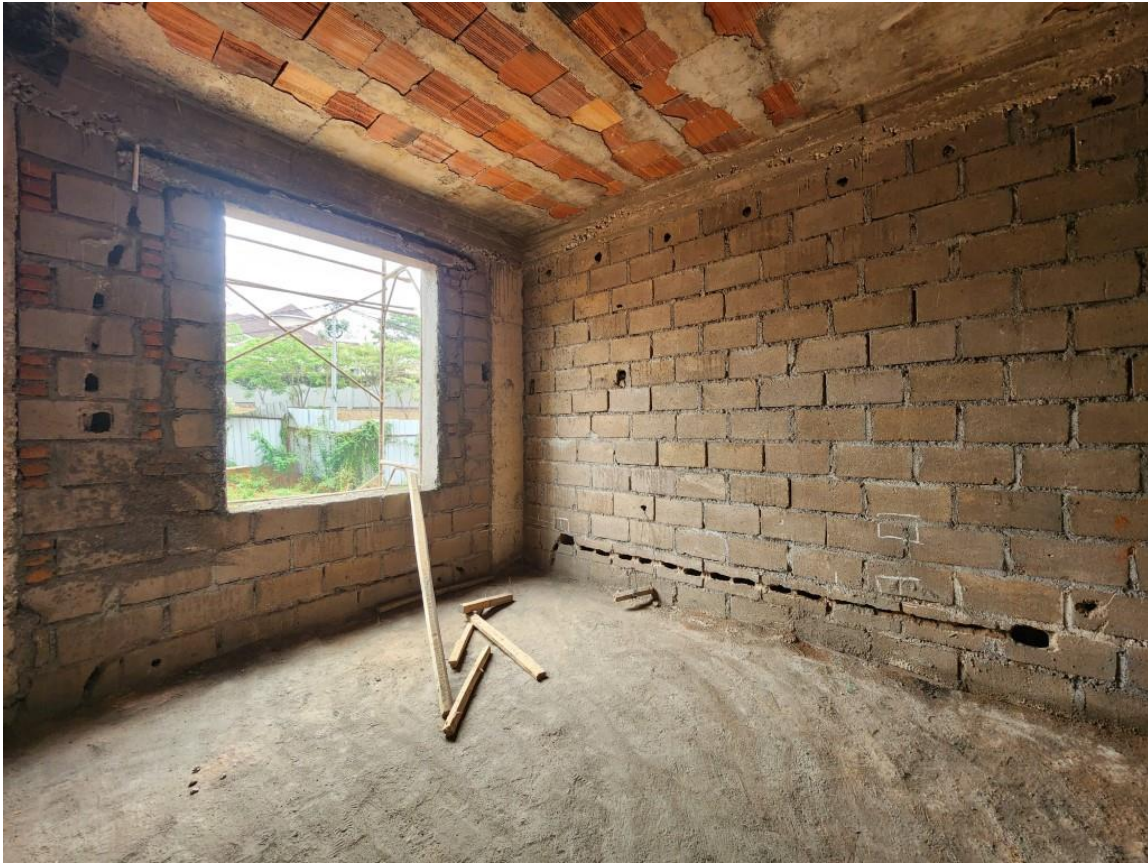
One of the bedrooms

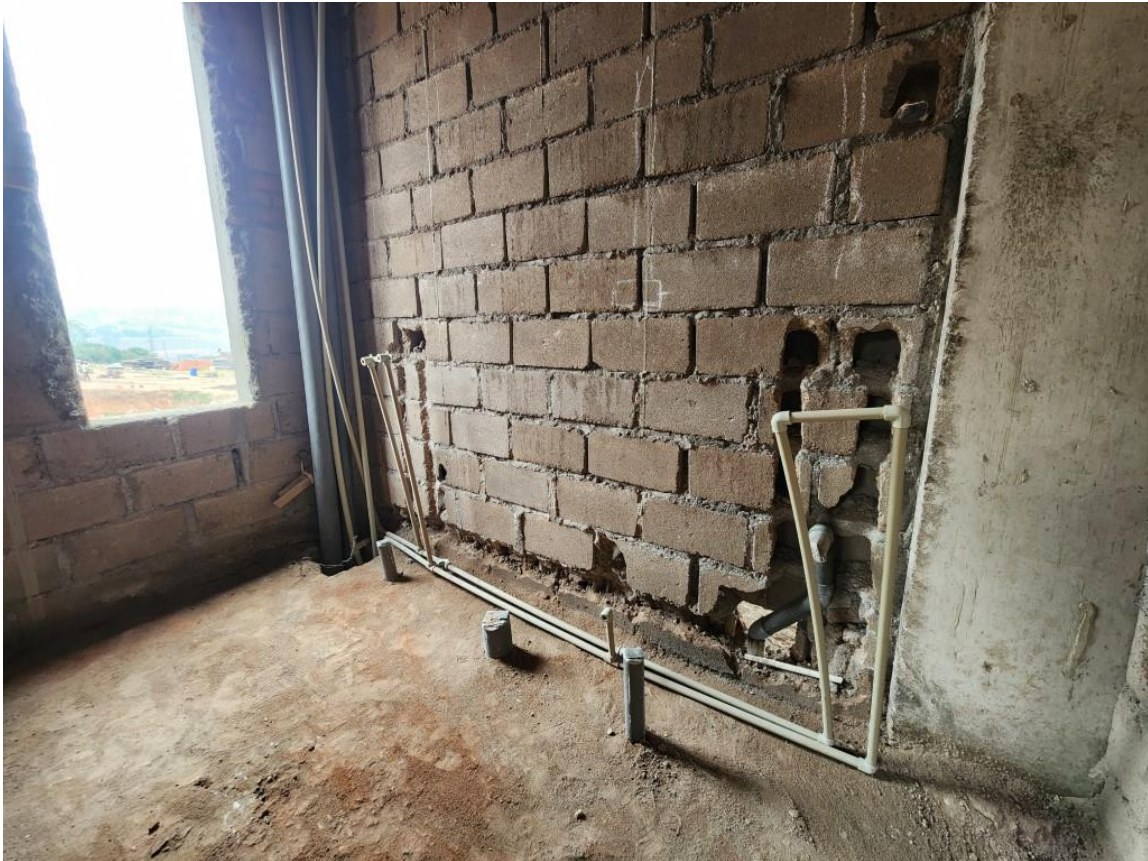
One of the bathrooms, with plumbing works ongoing

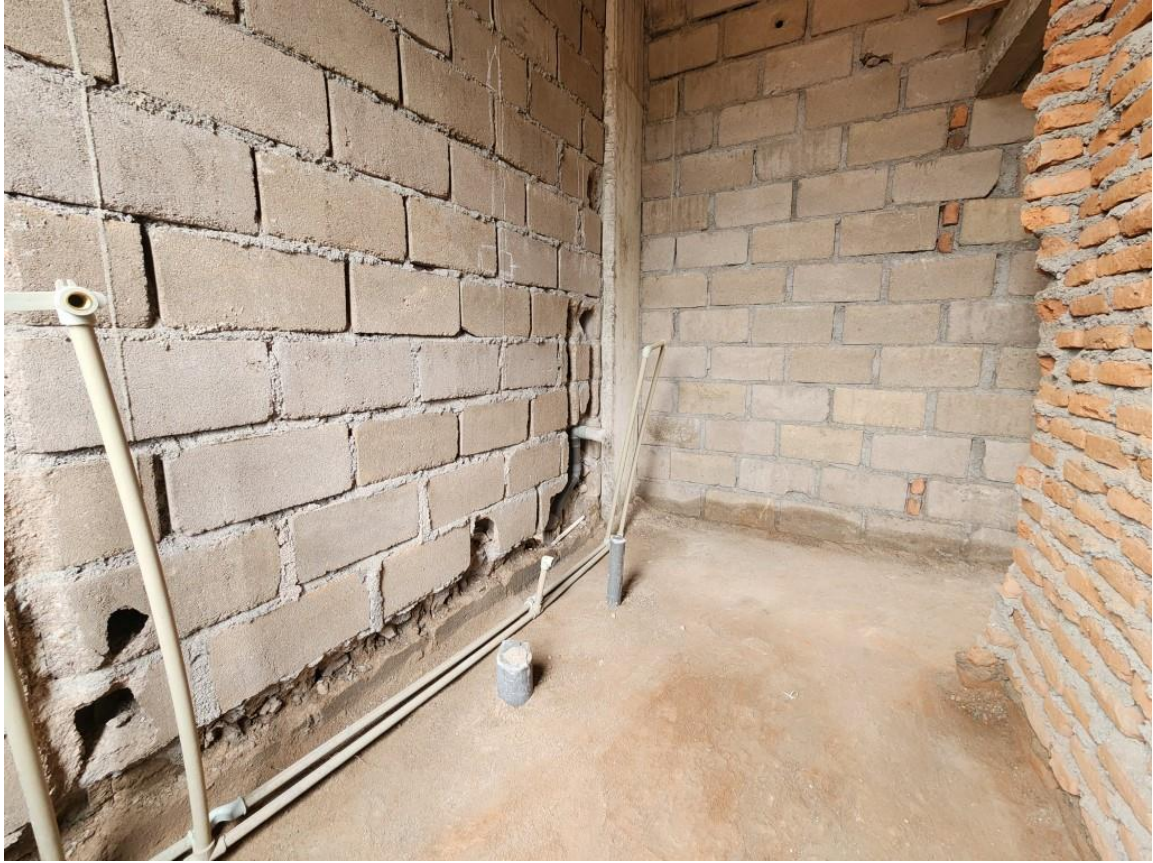
Bathroom

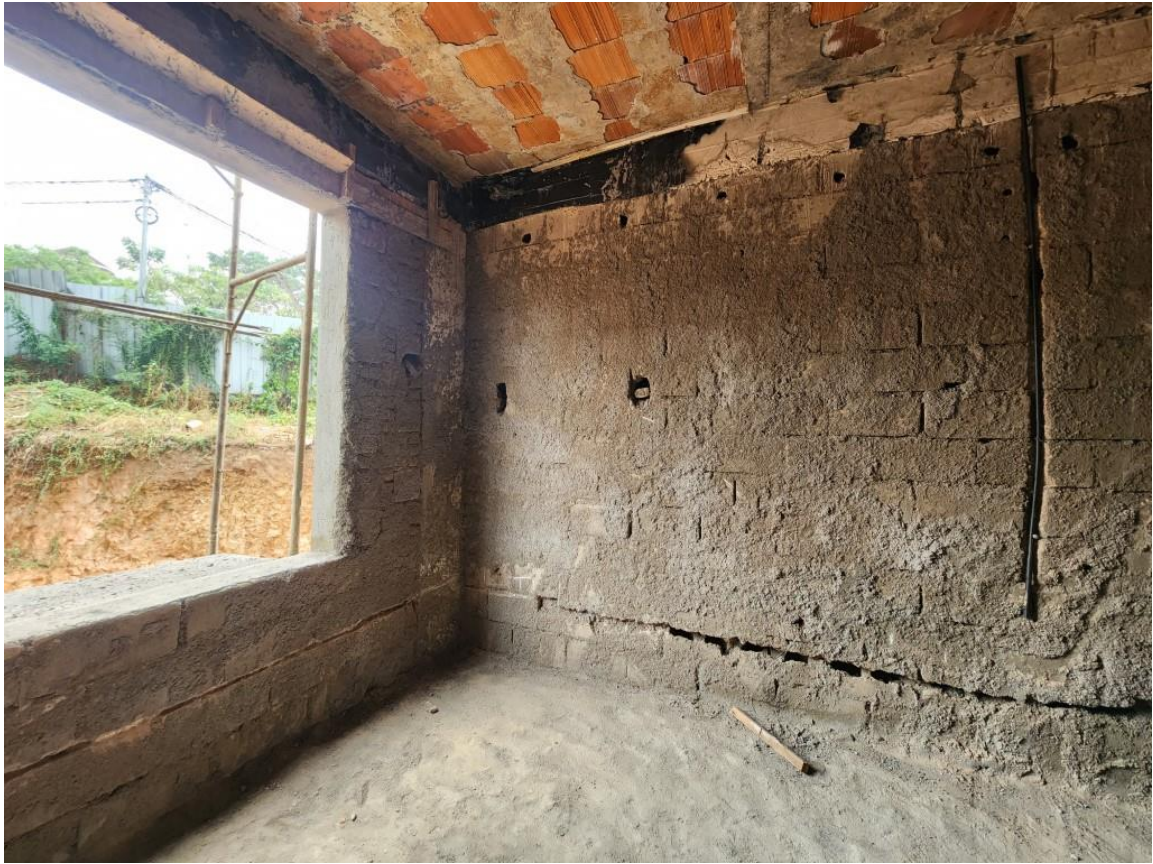
Electrical wiring in one of the bedrooms

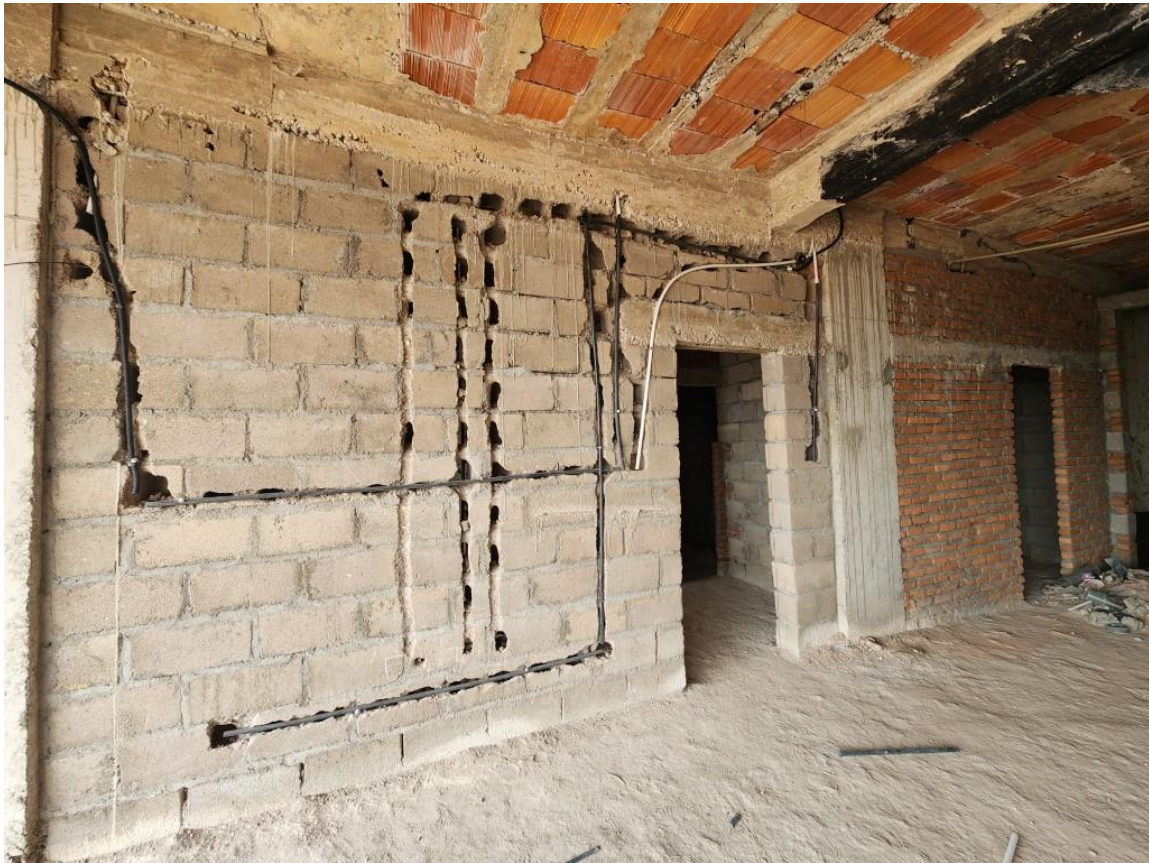
Electrical wiring in one of the living areas
