**NYARUTARAMA**

**PROGRESS REPORT**

**November 2025**

Harrington Golf Residence features 96 premium, exclusive 2 and 3 bed, all ensuite apartments with separate guest cloak and laundry rooms. The units boast of impeccable finishing and large windows offering expansive panoramic views of the golf course across the living, dinning, kitchen areas, letting in plenty of natural light. Well-manicured outdoor garden and sitting spaces, recreational facilities such as swimming pool, children playground and a landscaped backyard offer the perfect recreation all within a secured, gated, highly private community with 24-hour CCTV surveillance and ample parking spaces

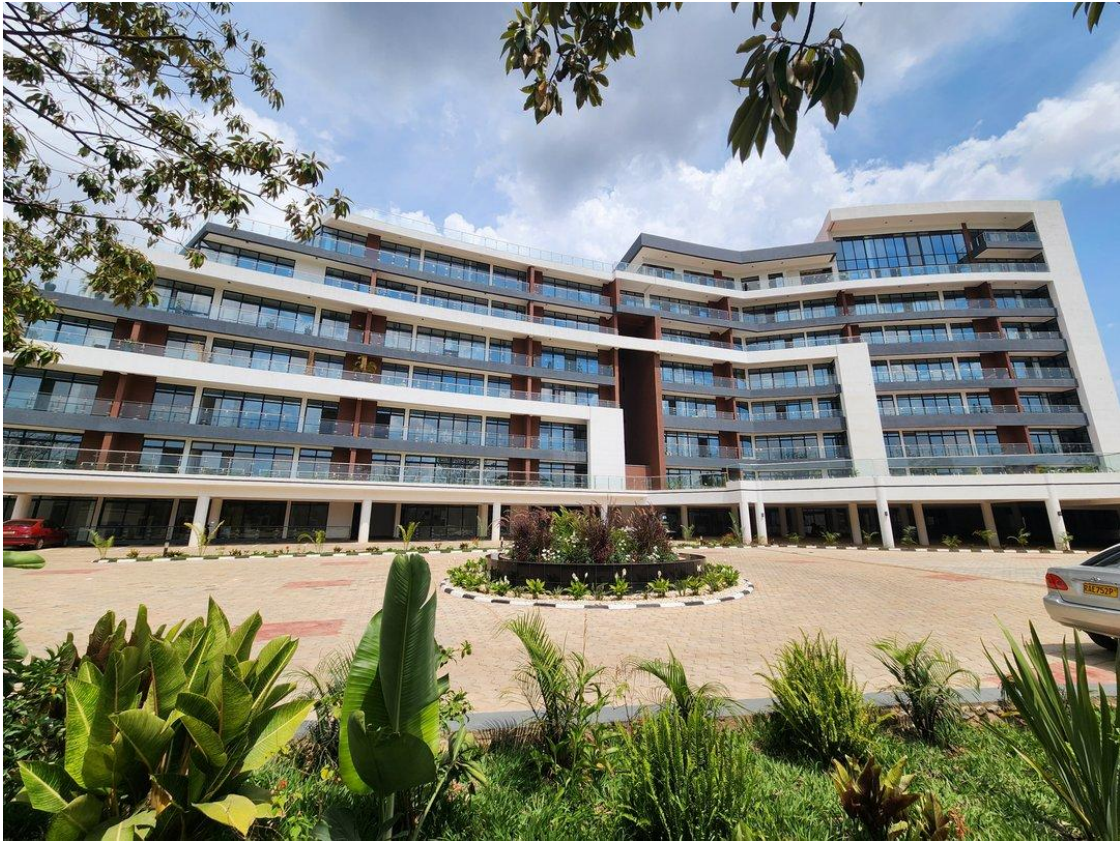
View of Phase 1 and 2

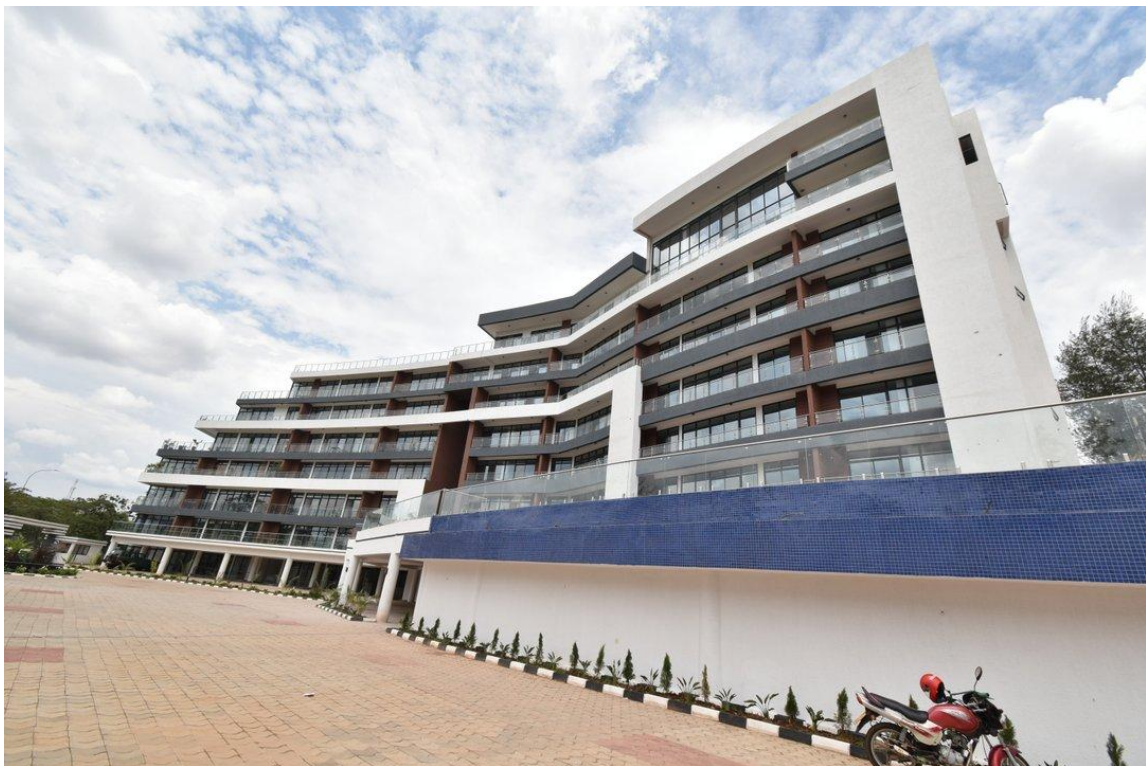
View of Phase 1 and 2

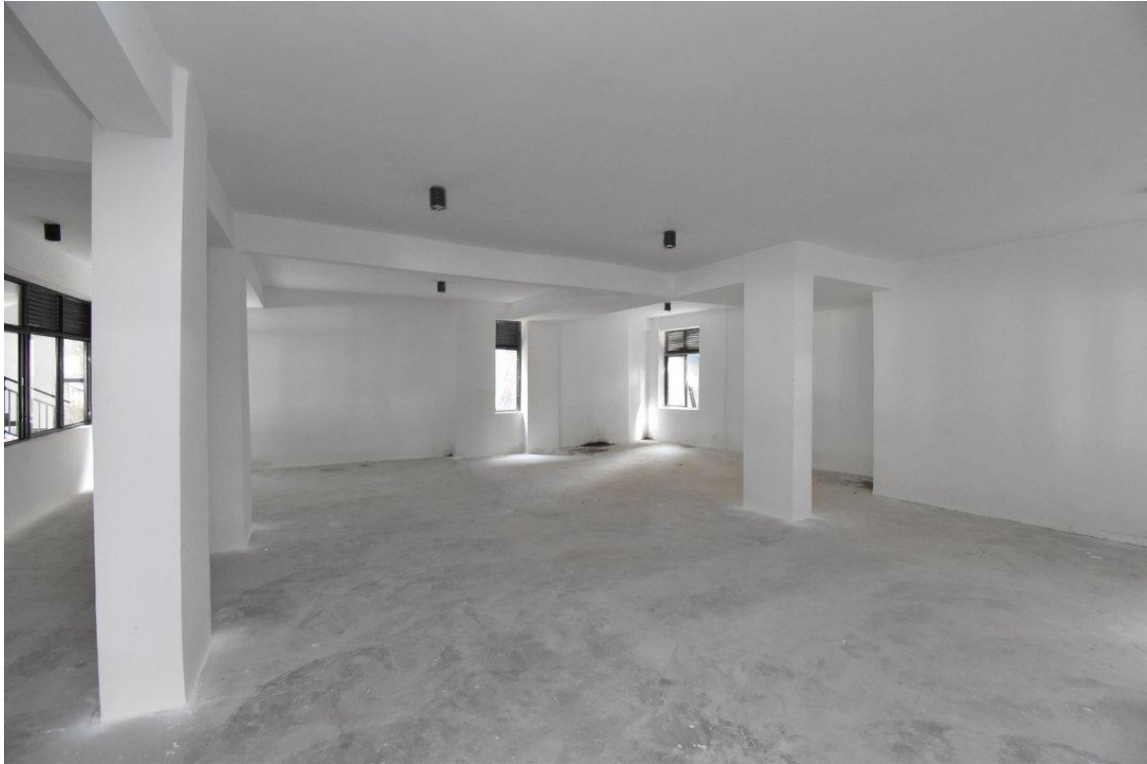
The Gym

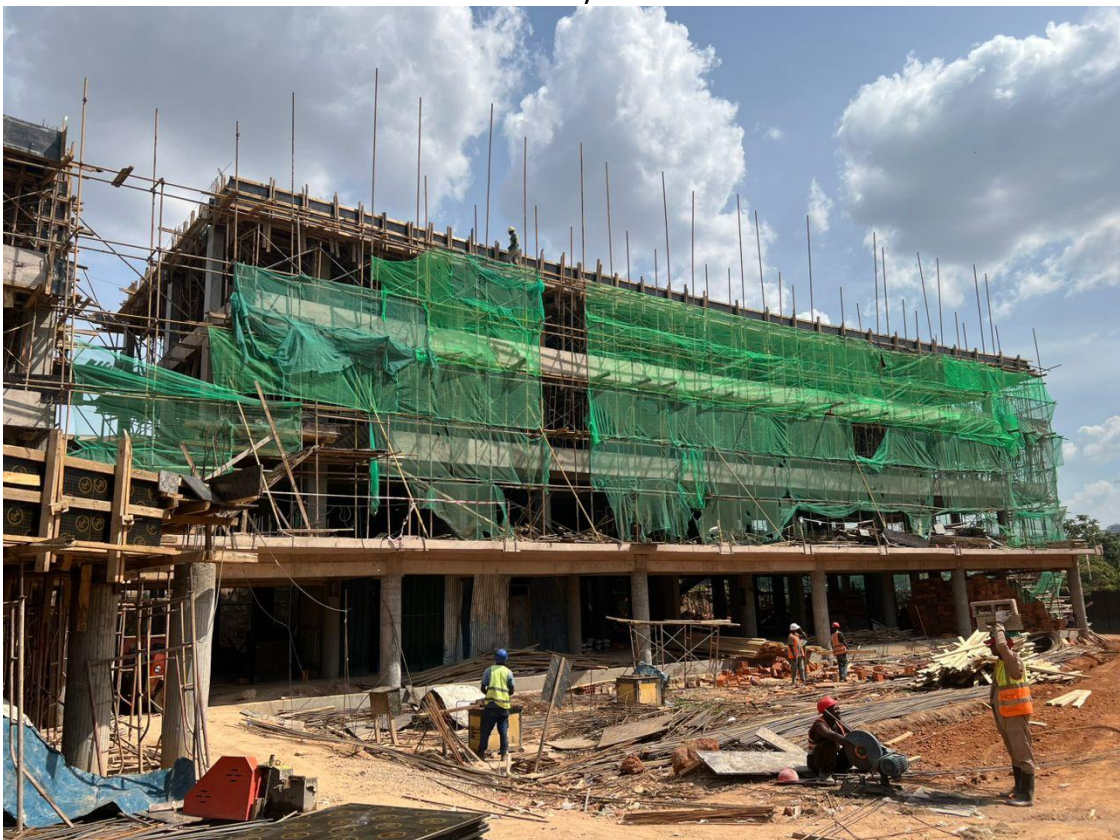
View of Phases 3 and 4

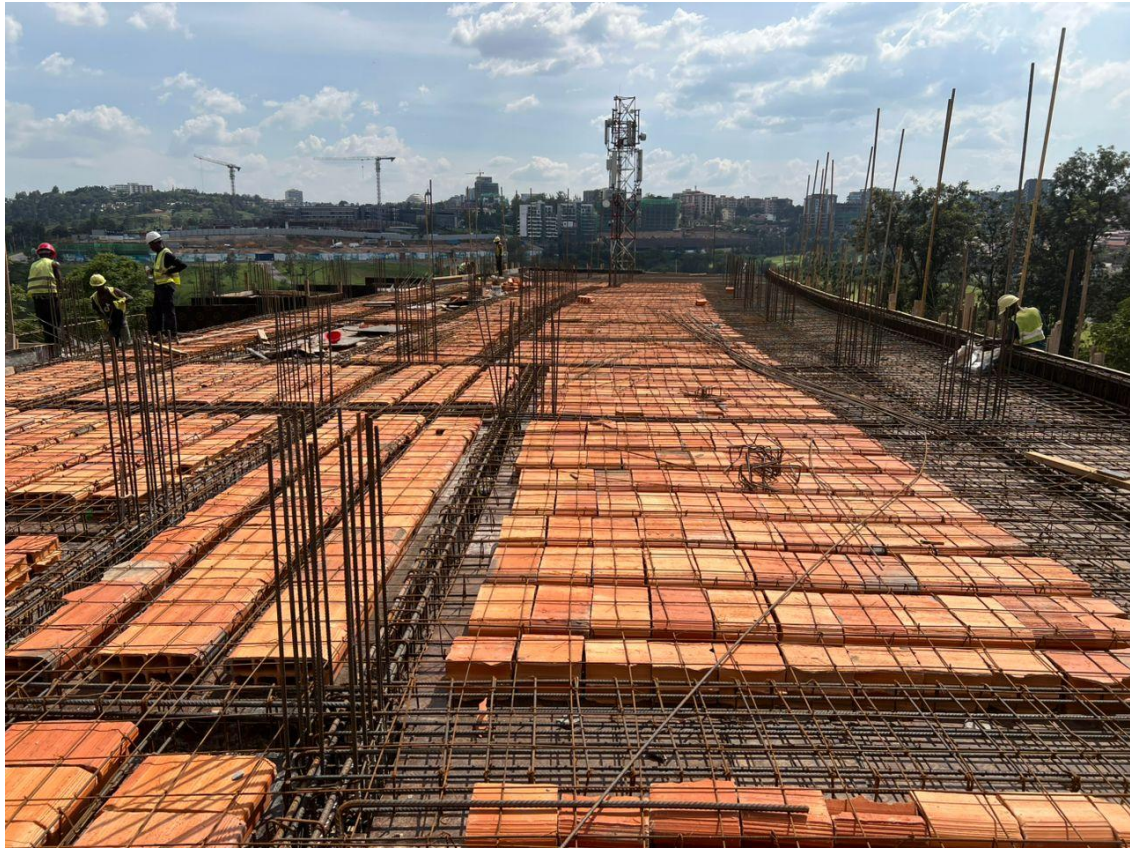
Phase 3/4 works showing: Formwork & steel reinforcement for slab on Lv. 5

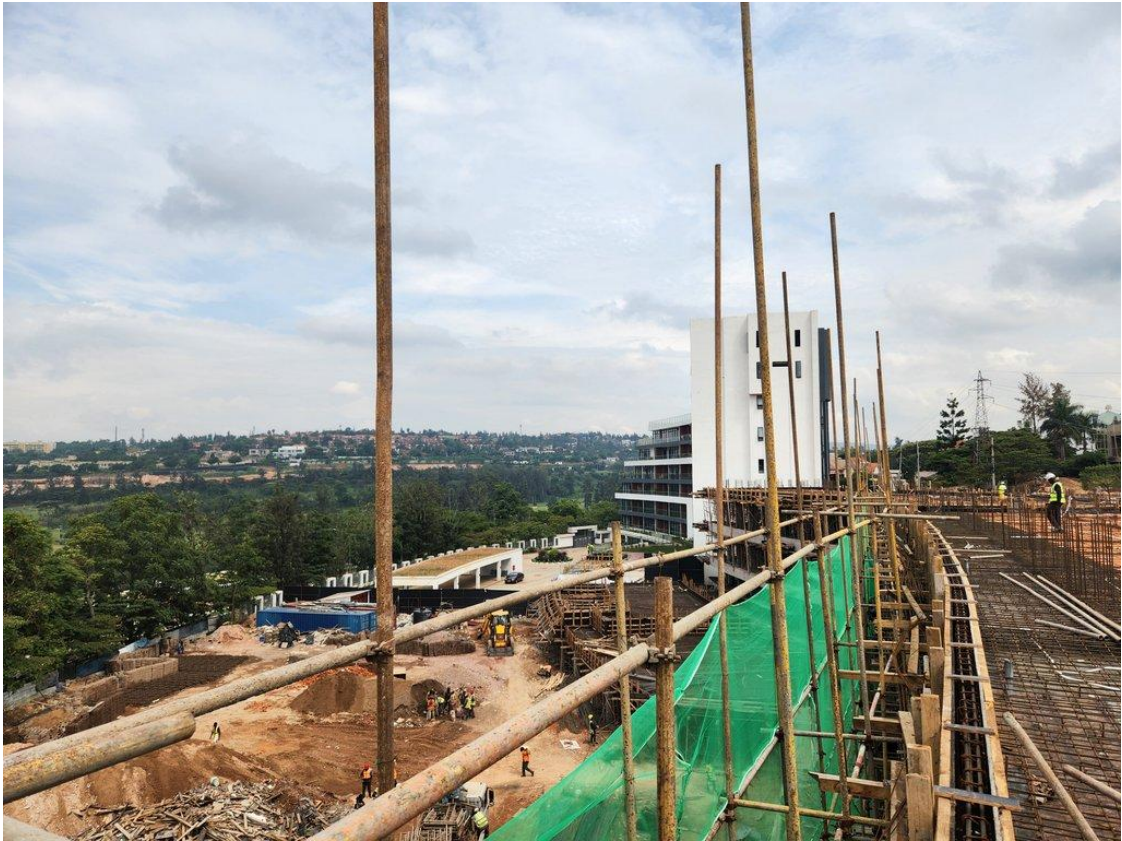
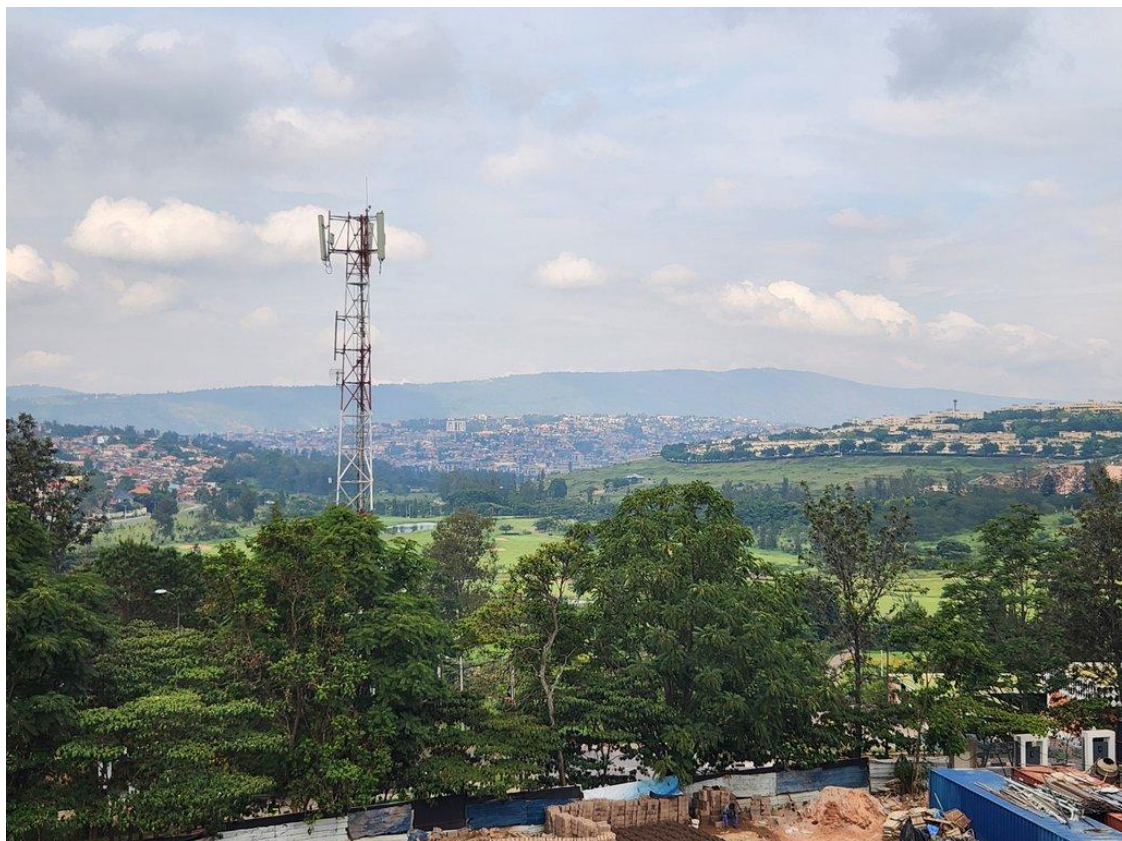
Views from the 4<sup>th</sup> floor, phase 4

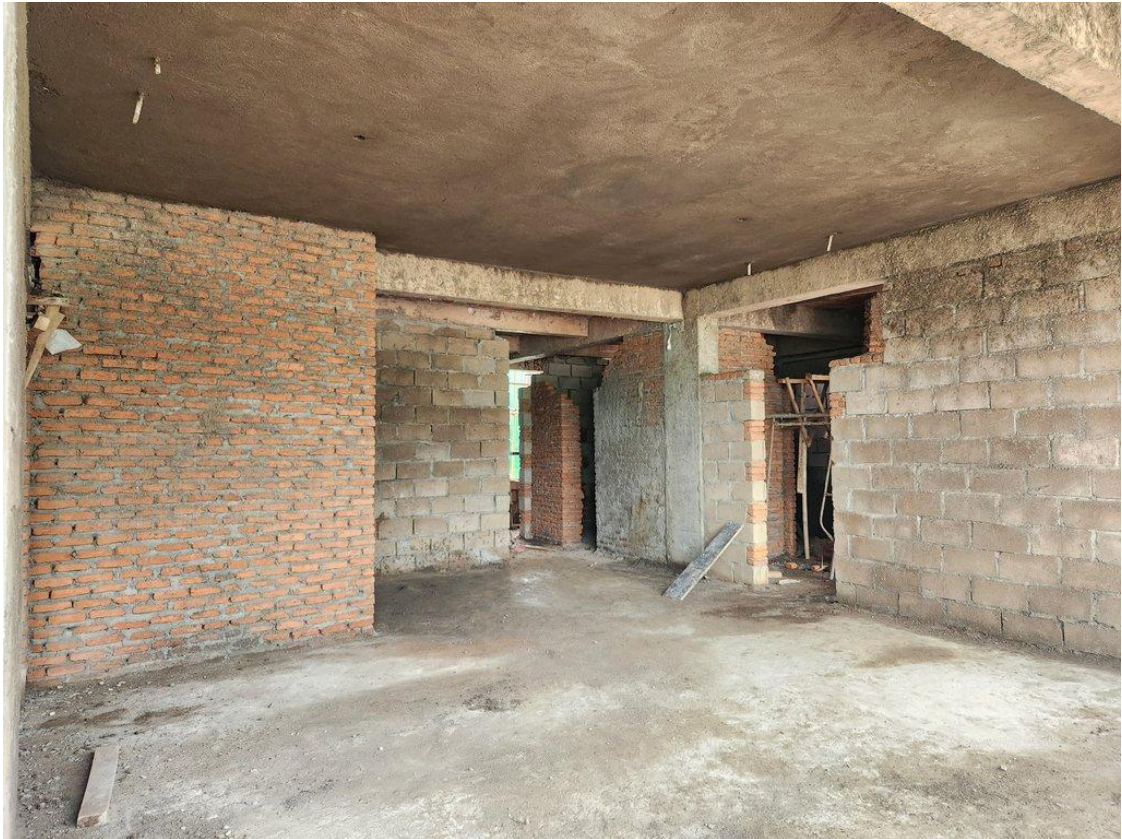
Internal walling ongoing, Phase 3 and 4

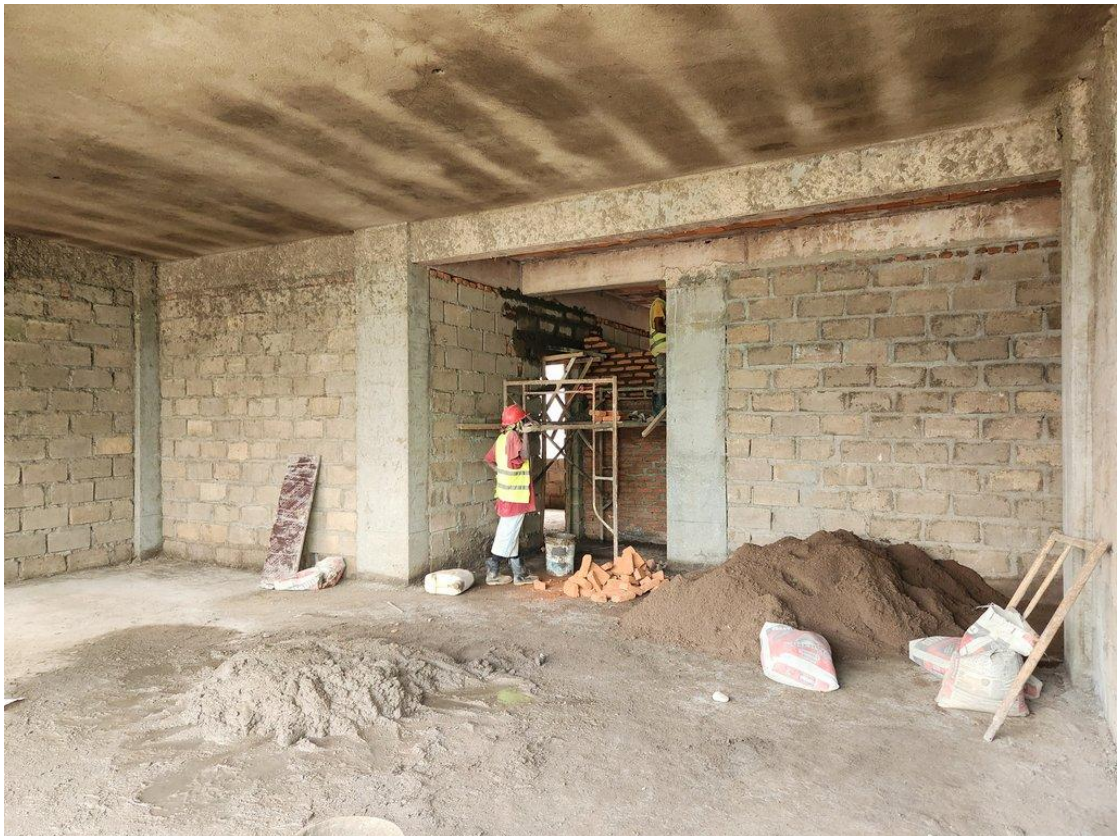
Internal walling Phase 3 and 4

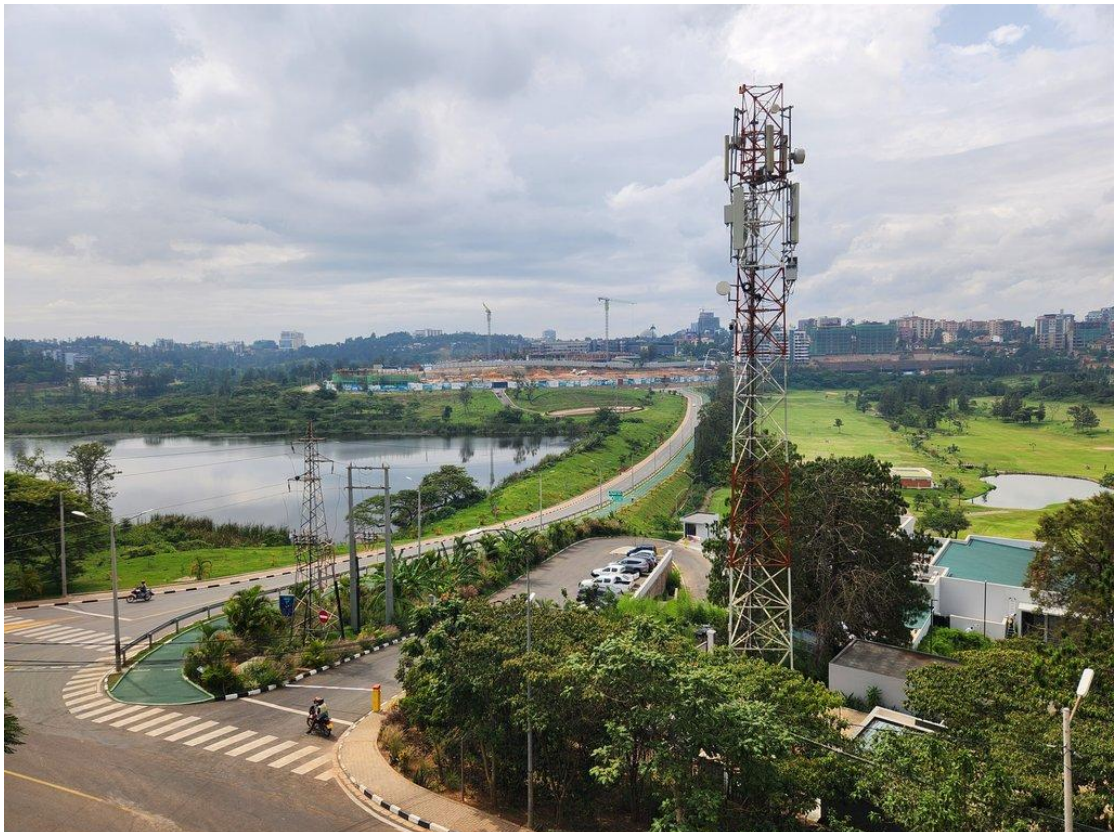
Views from Phase 4, terrace apartment 4<sup>th</sup> floor

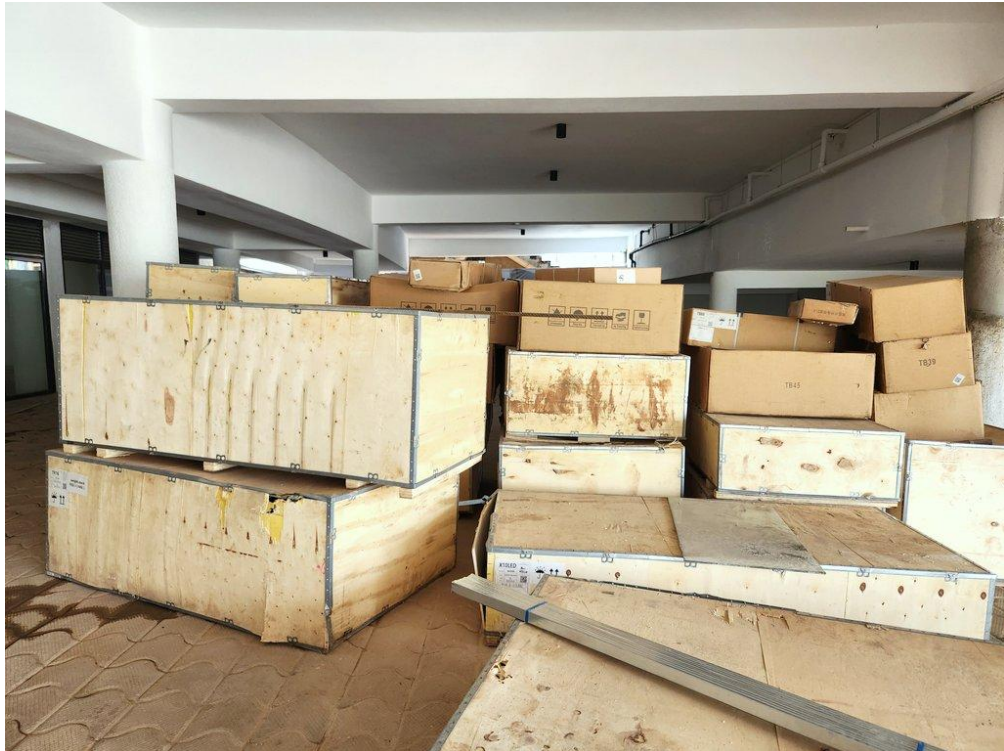
The Gym equipment, already at site.

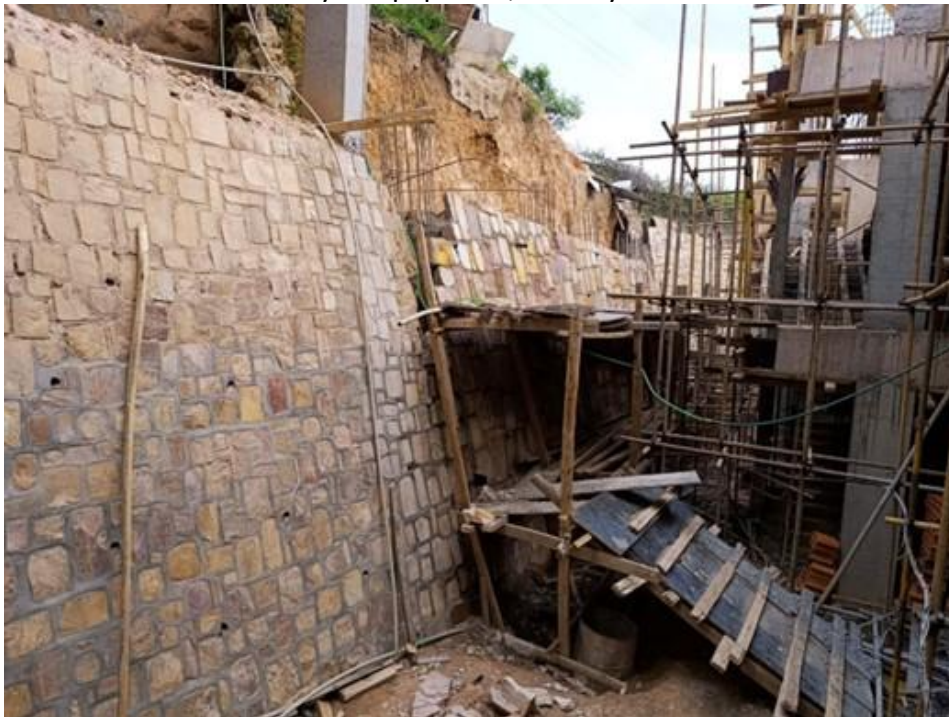
Phase 3 works showing: Masonry walling of retaining wall
