HARRINGTON
GOLF RESIDENCES

NYARUTARAMA

PROGRESS REPORT
JULY - SEPTEMBER 2024

Phase 1 and 2.

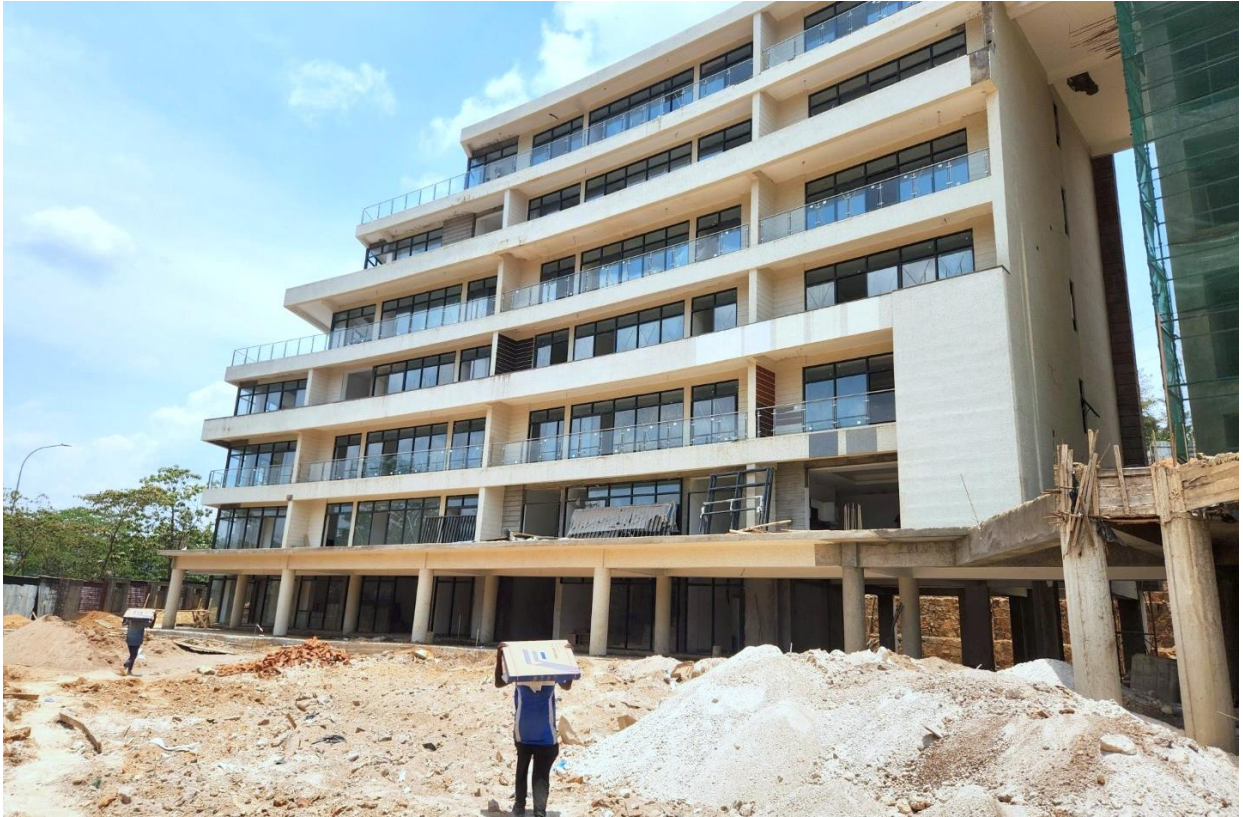
View of Phase 1

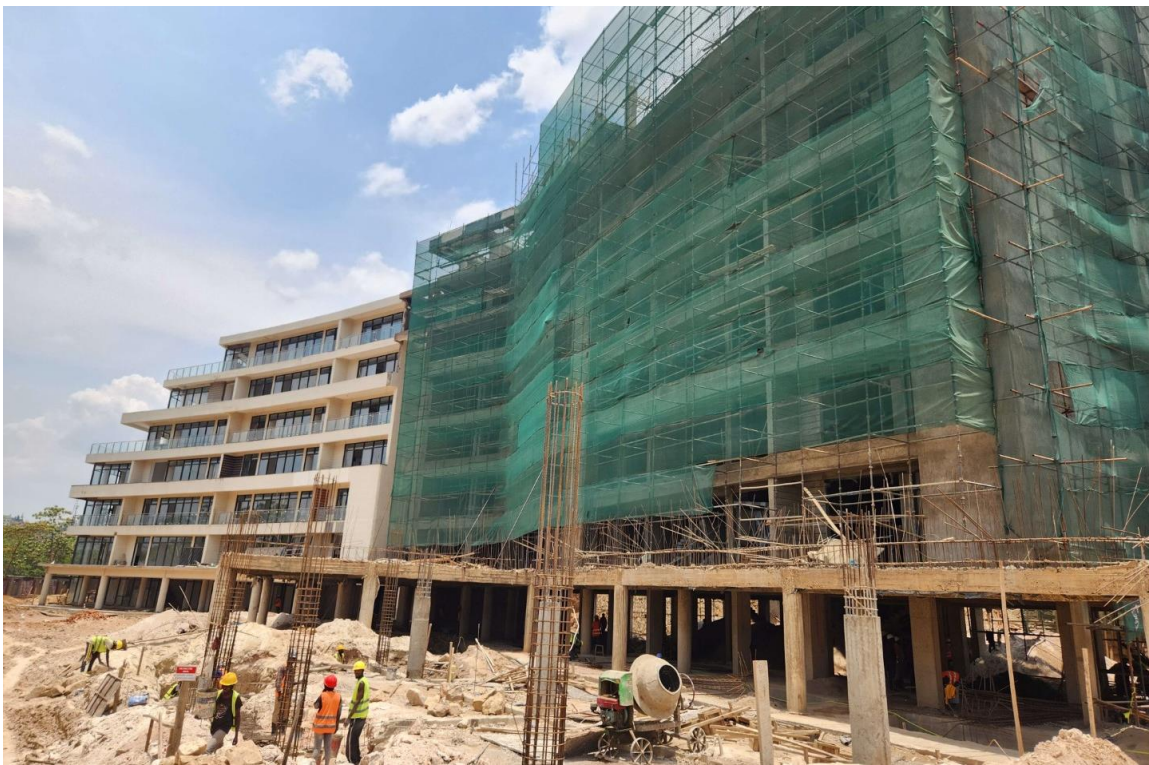
View of Phase 2

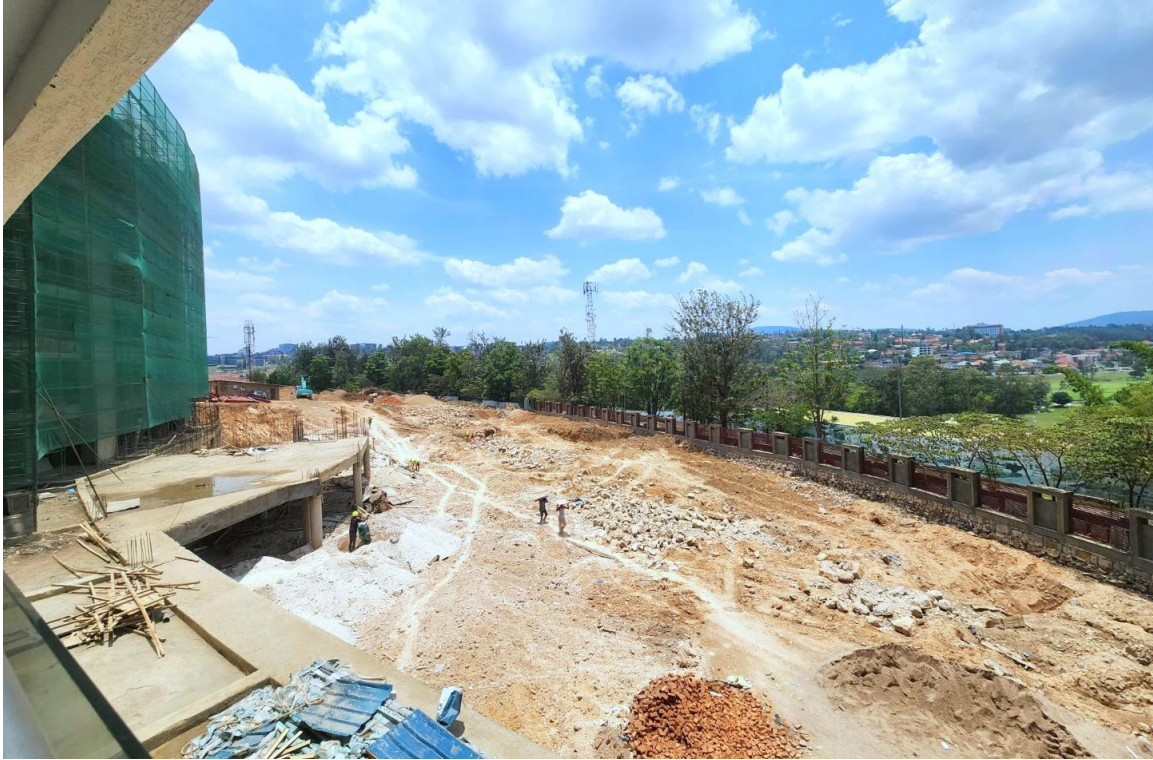
Townhouse villas demolished to increase the aesthetic appeal of the residences.

In liaison with the authorities, the developer agreed to remove the Villas to improve the views into and from the project. They shall be replaced with single-level high-end commercial spaces.

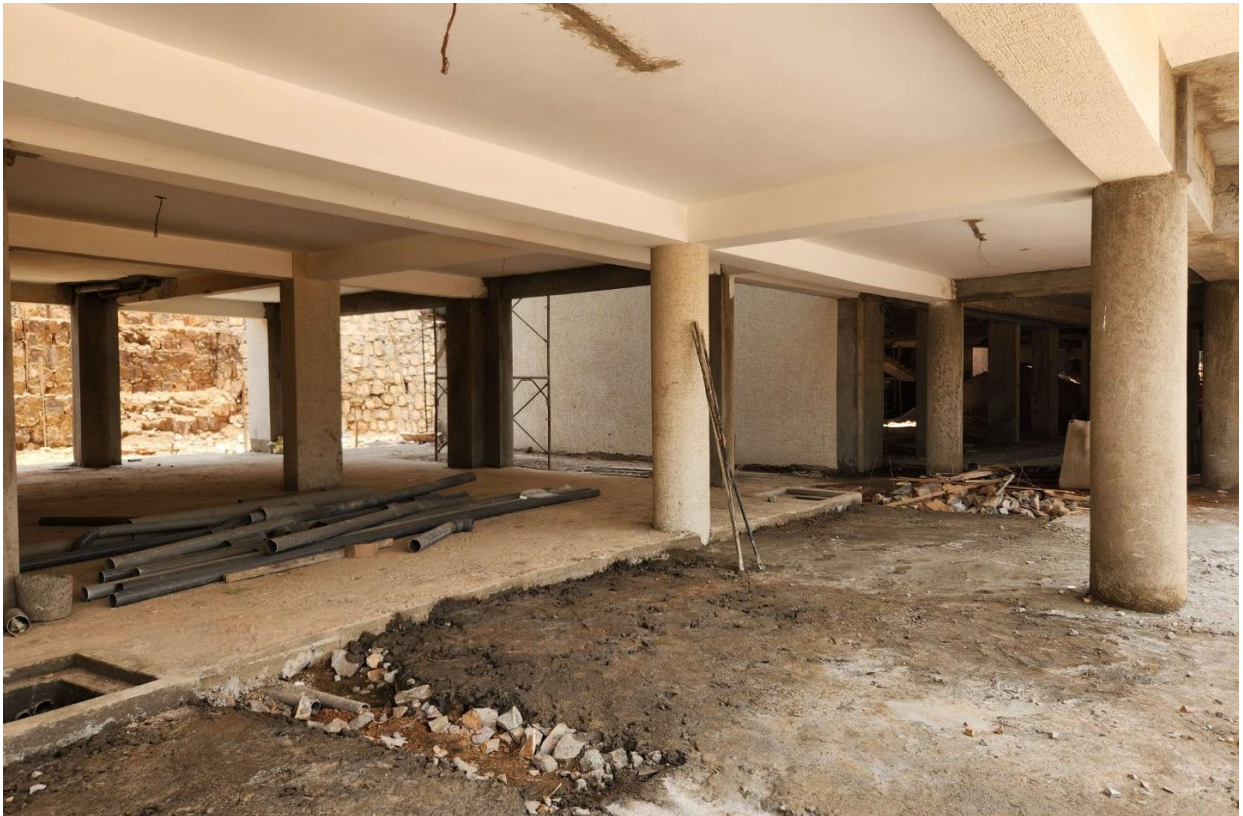
Basement Parking screeding and covering of water pipes

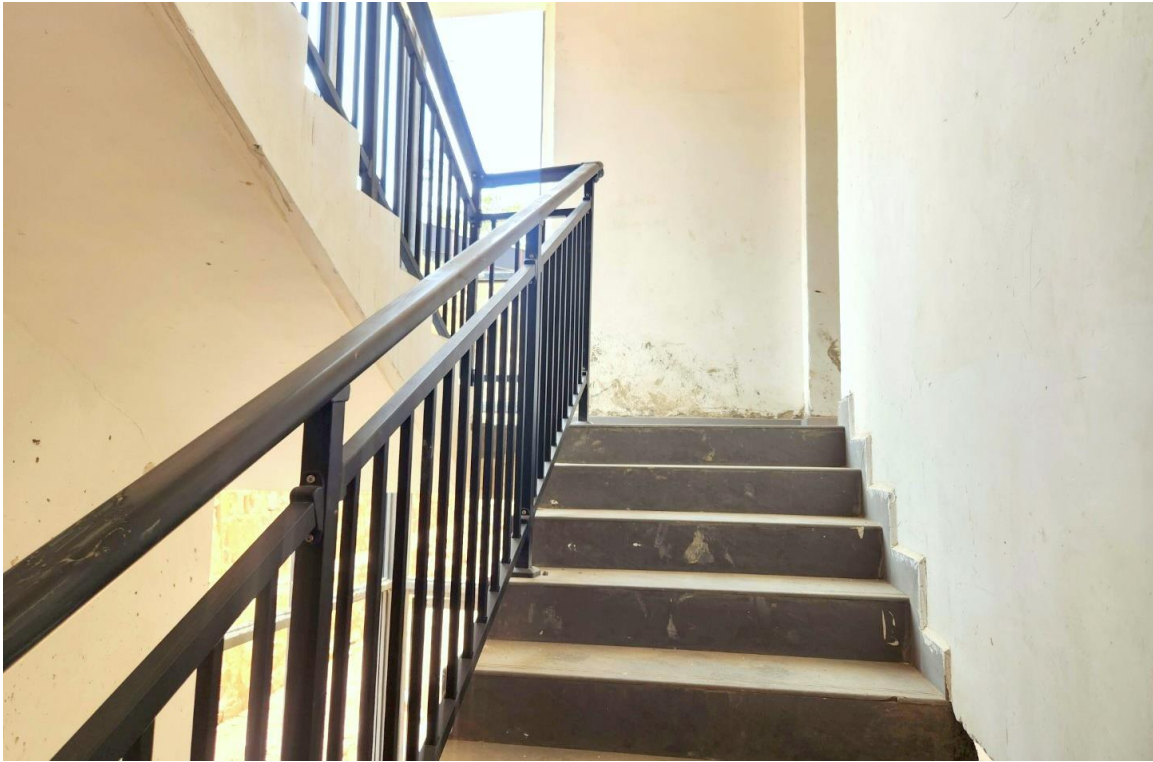
Staircase railing in Phase 1 in place

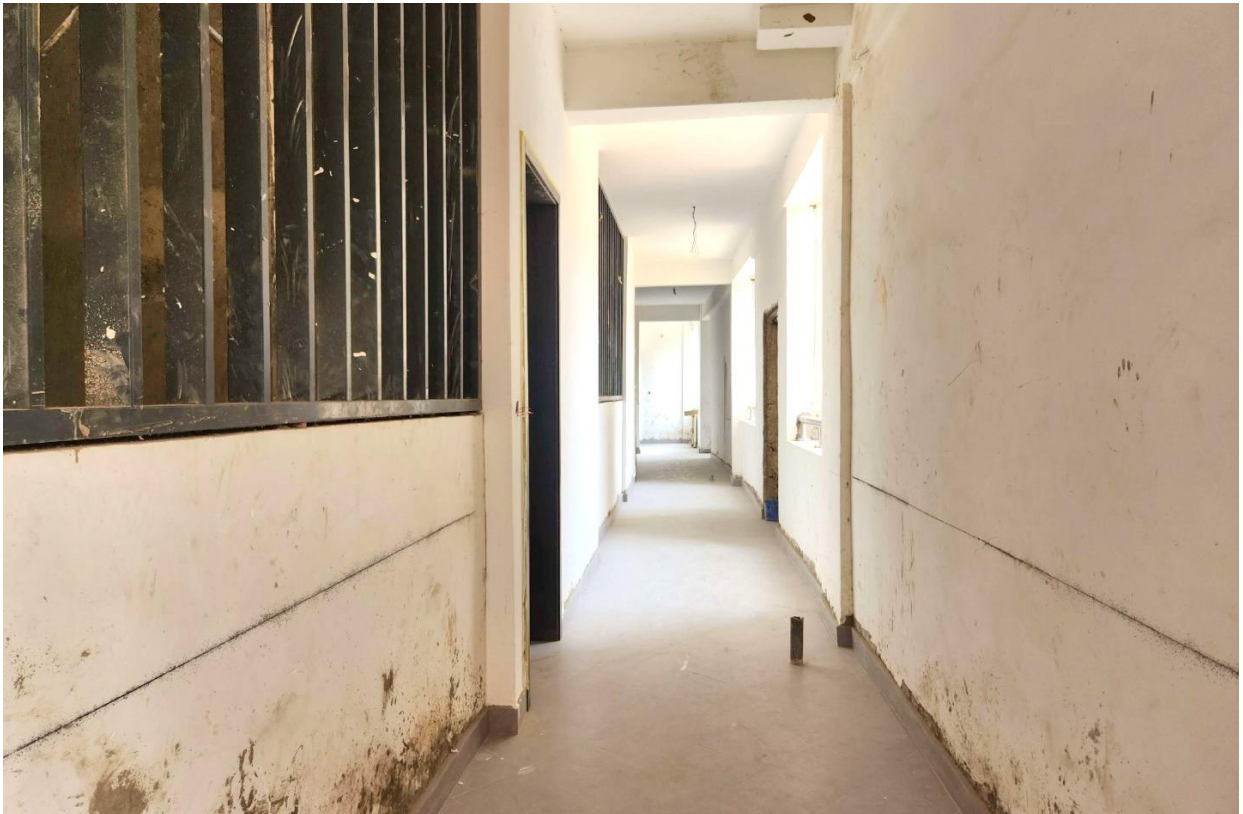
Corridor tiling and void covers in Phase 1

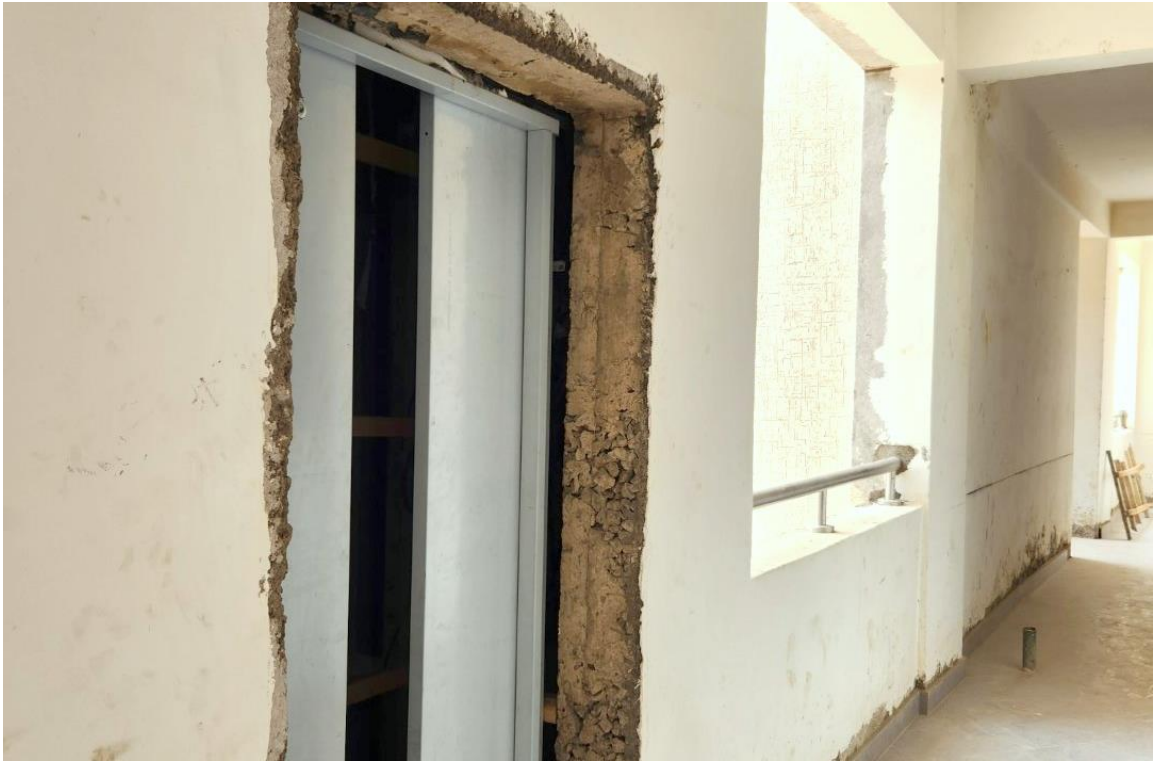
Elevator Installed, pending exterior finish for Phase 1

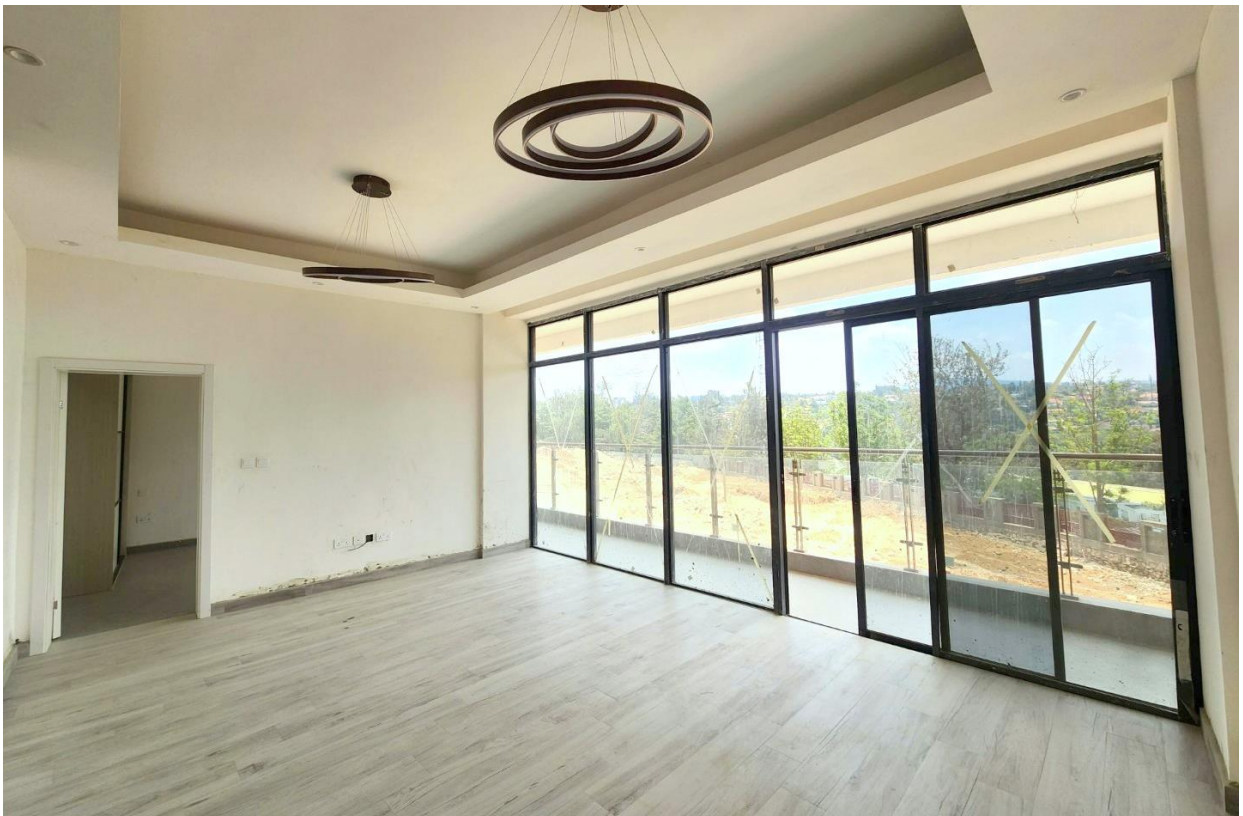
Living room with Lights installation ongoing.

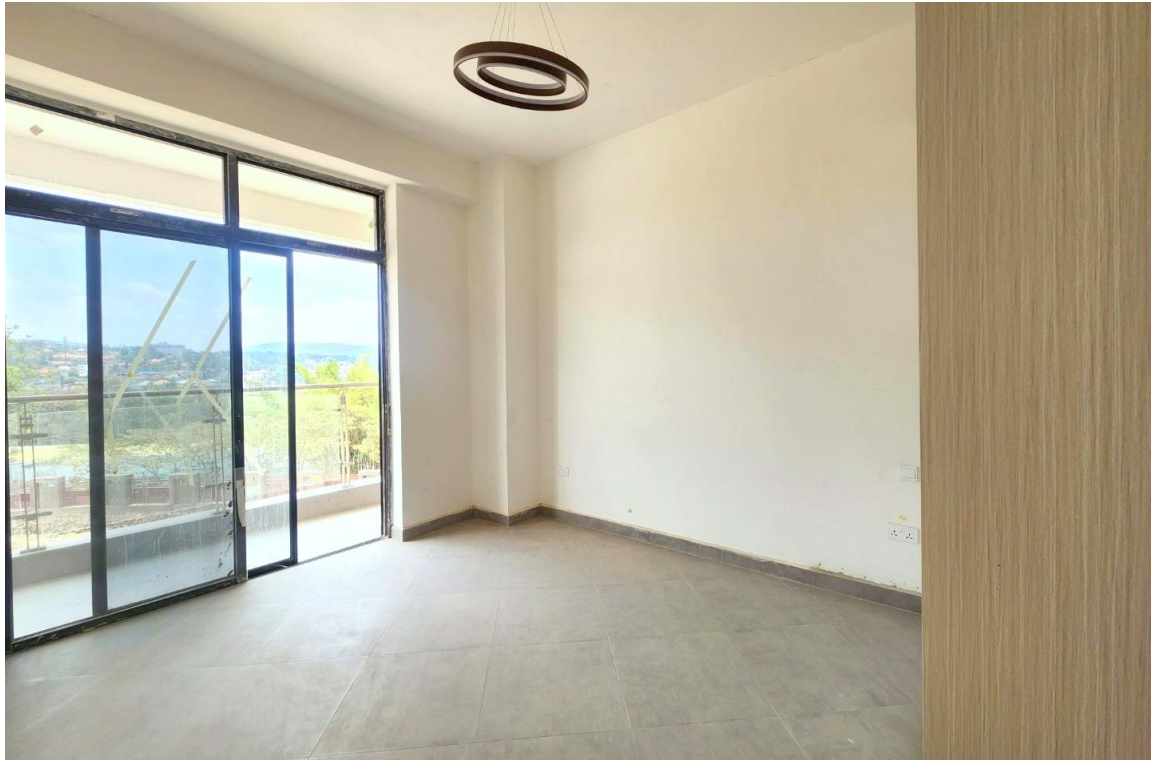
One of the bedrooms, with lights installed

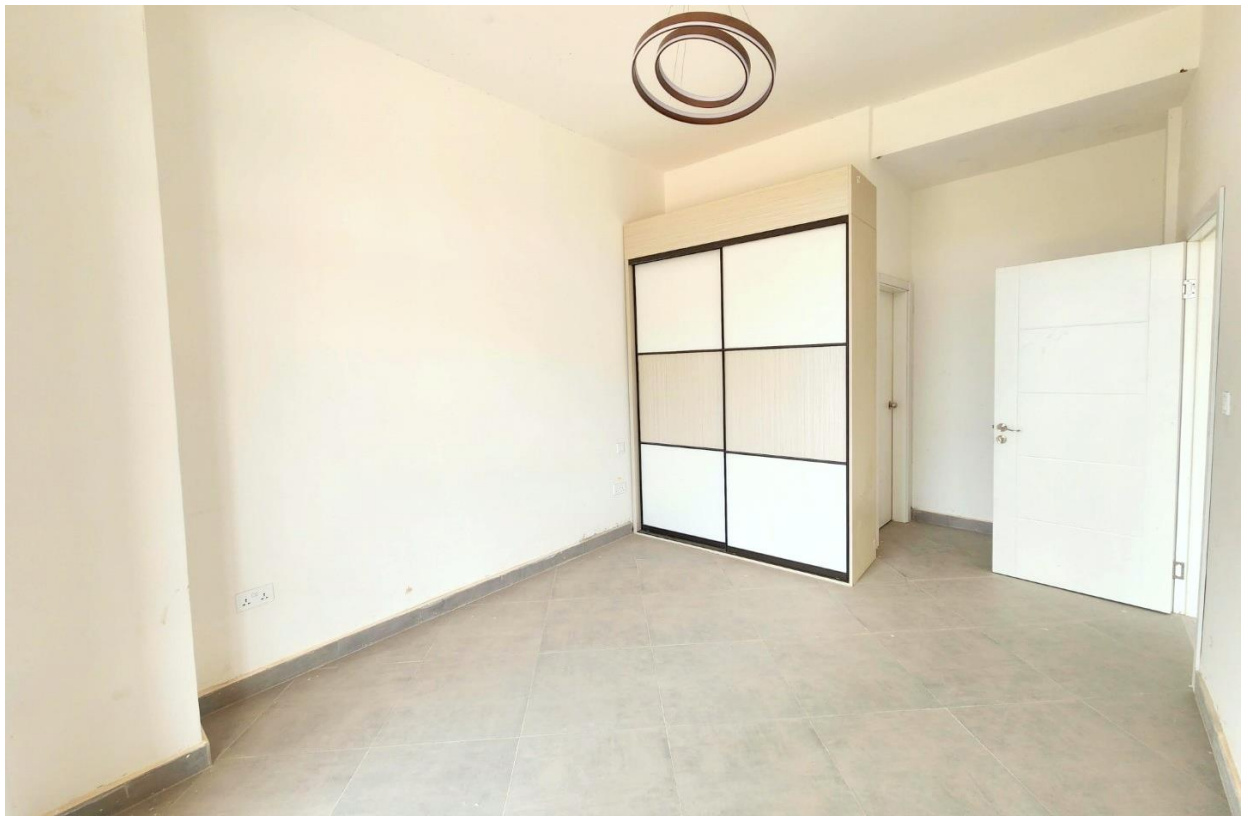
Phase 1 bedroom showing lights and wardrobes installed

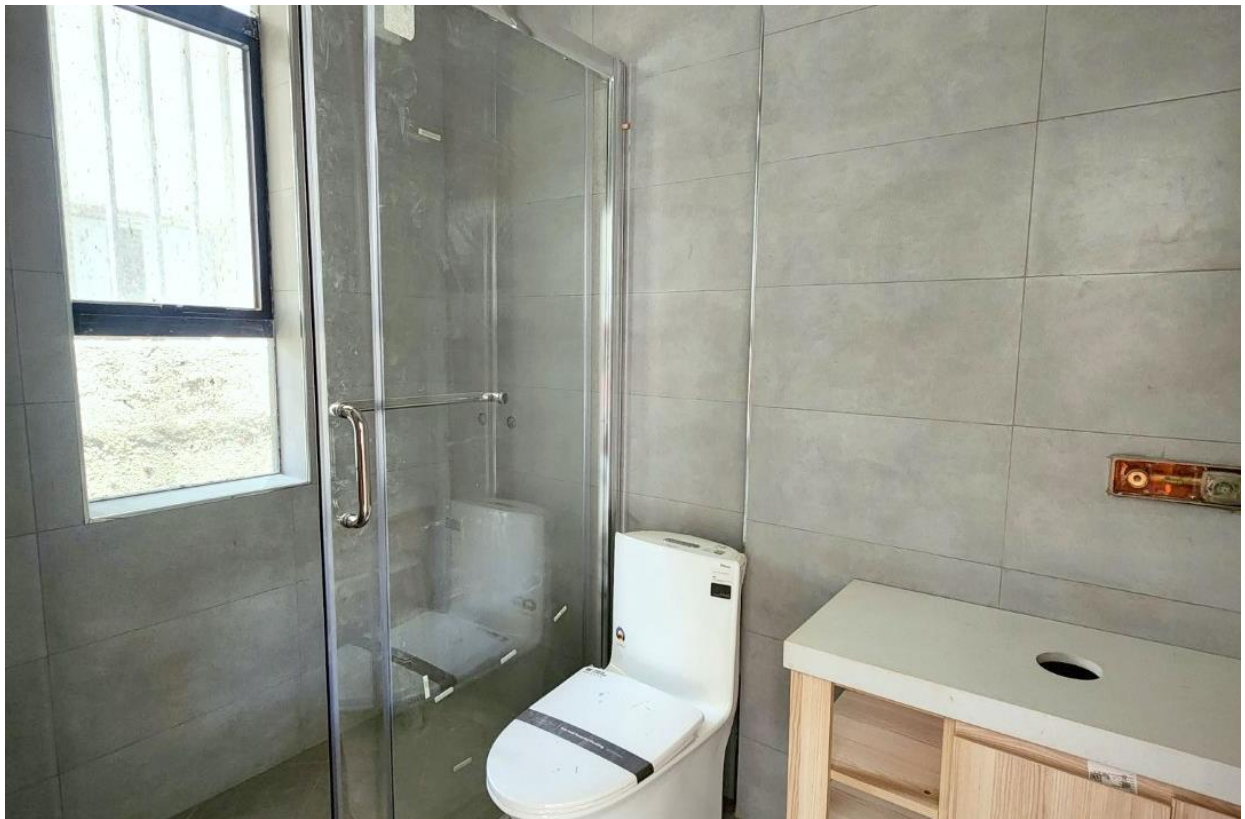
Shower glass and toilet in one of the bathrooms, Phase 1

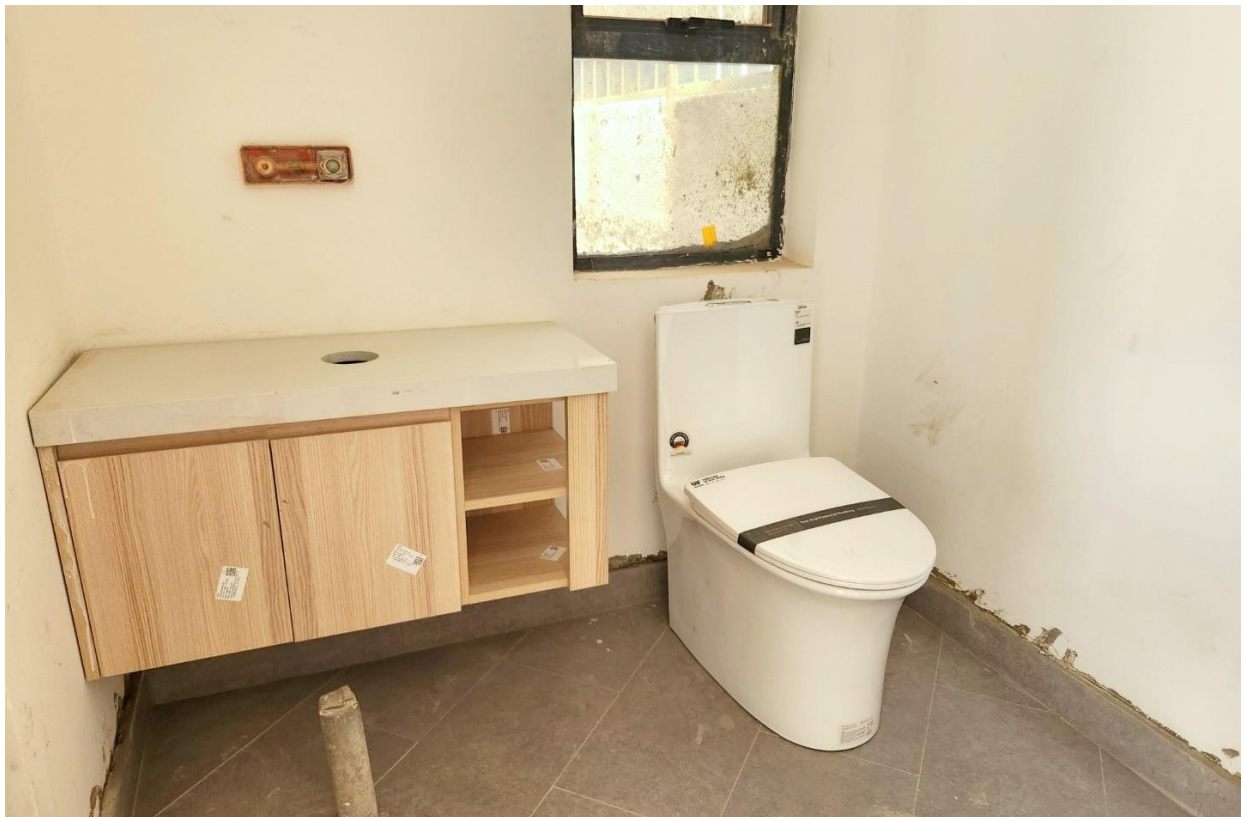
Phase 1 showing the guest toilet.

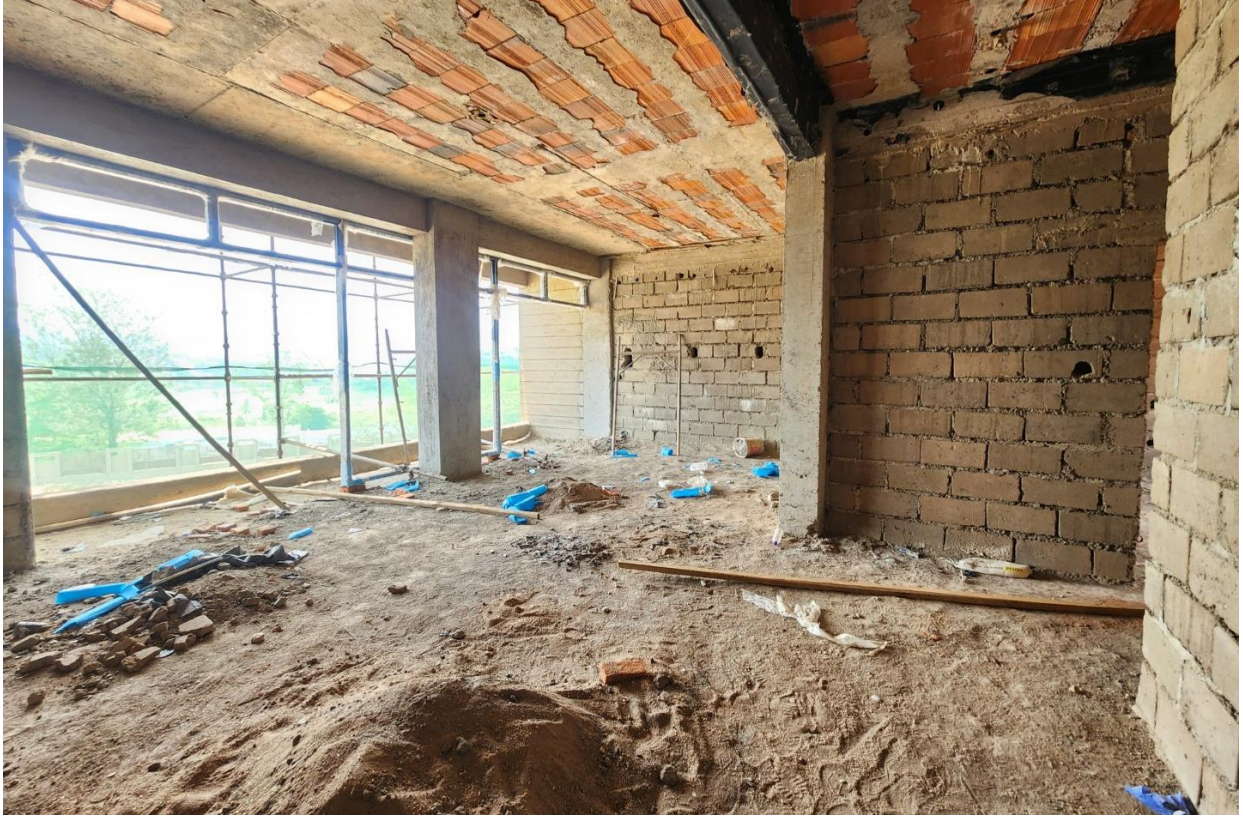
Phase 2 works, showing the curtain wall installation works ongoing

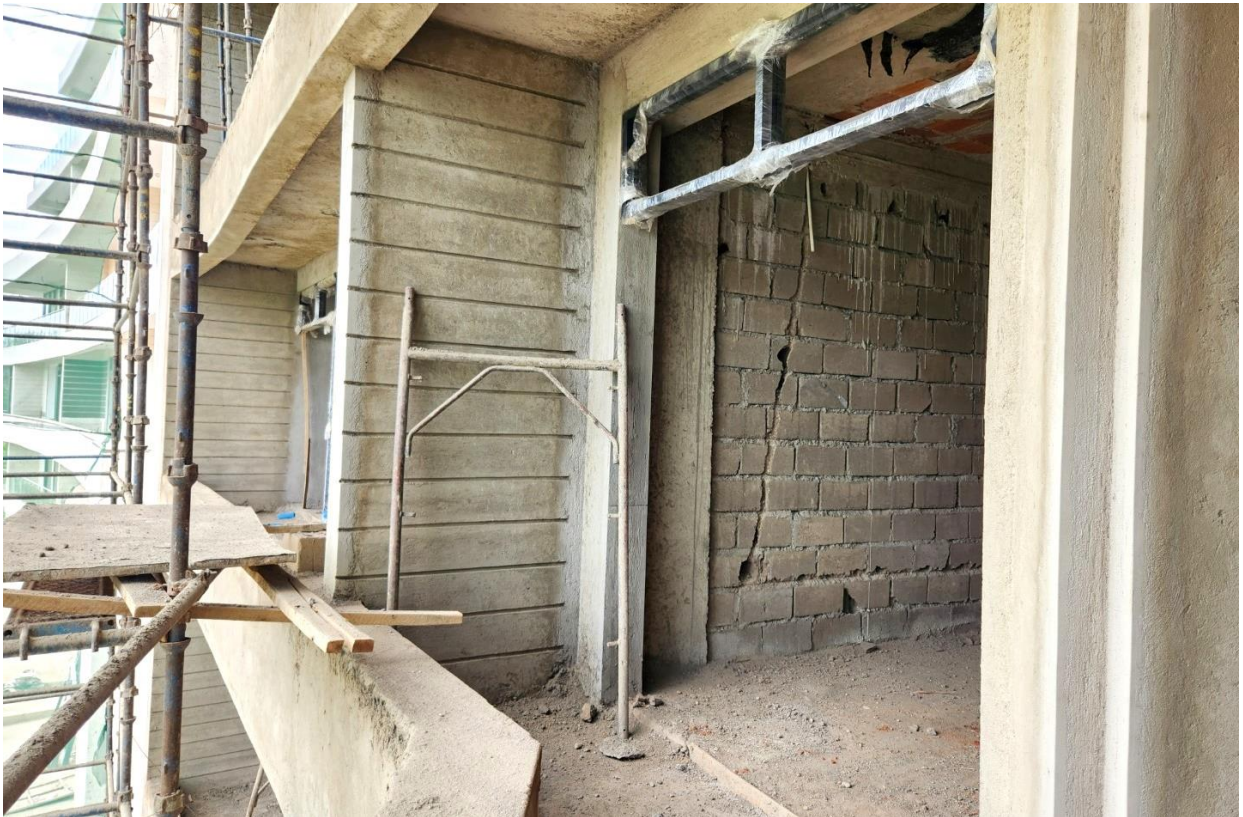
Phase 2 works showing plastering and curtain walling works
