NYARUTARAMA

PROGRESS REPORT
JANUARY 2025

PROGRESS REPORT

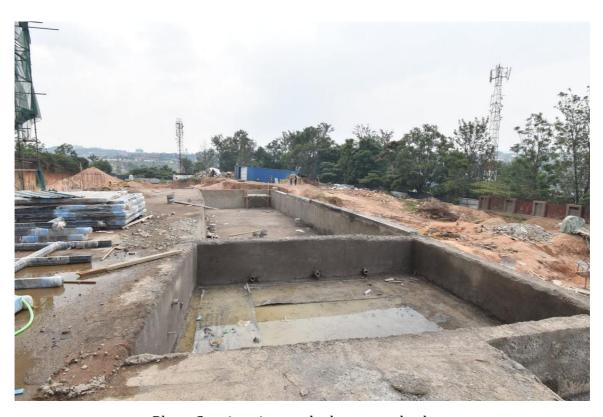
Phase 2 swimming pool, plaster works done

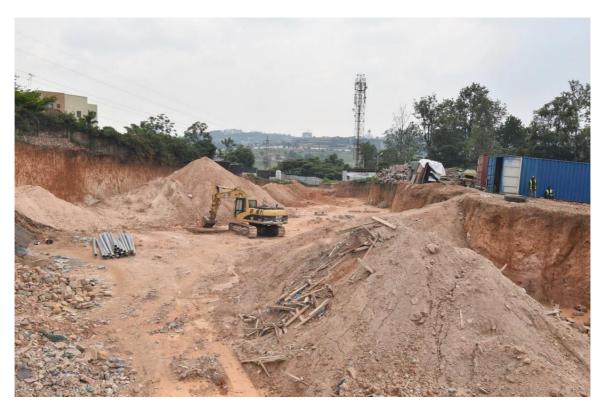
Phase 3 & 4 works showing: Mass excavation to reduce soil levels to Basement 3

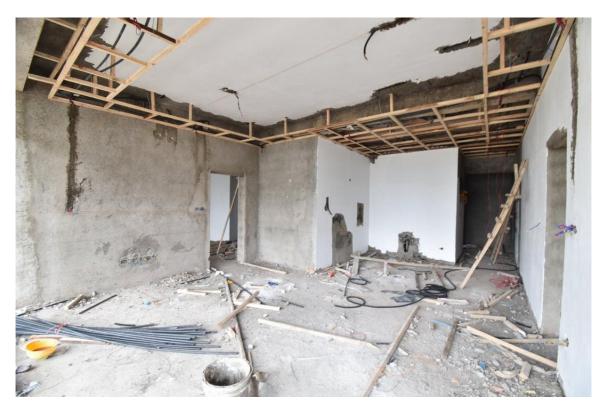
One of the Phase 2 units, showing plastering works done and painting

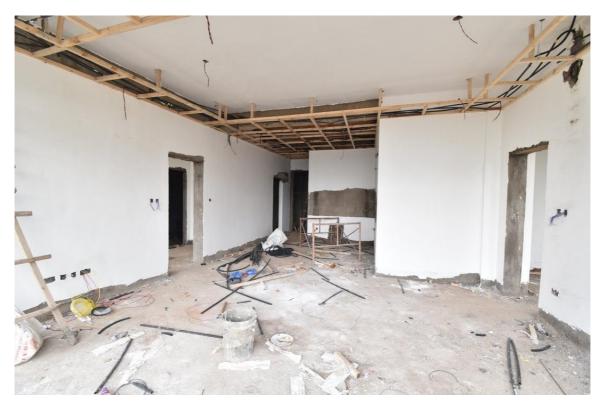
One of the units in Phase 2, with painting ongoing.

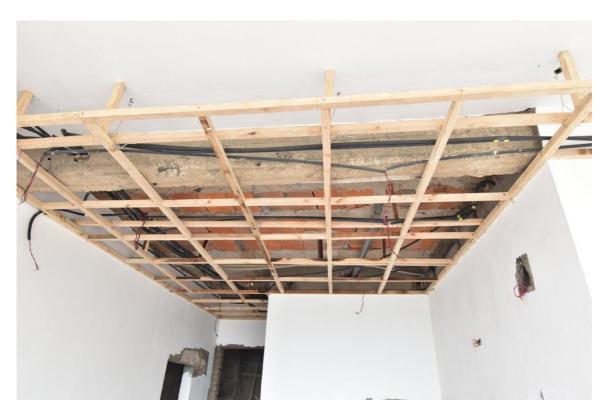
Phase 2 gypsum blundering ongoing.

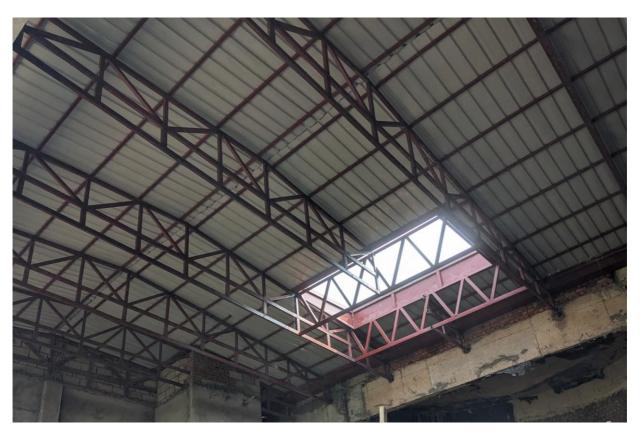
Phase 2 works showing: Roof truss installed in Lv. 2 of penthouse

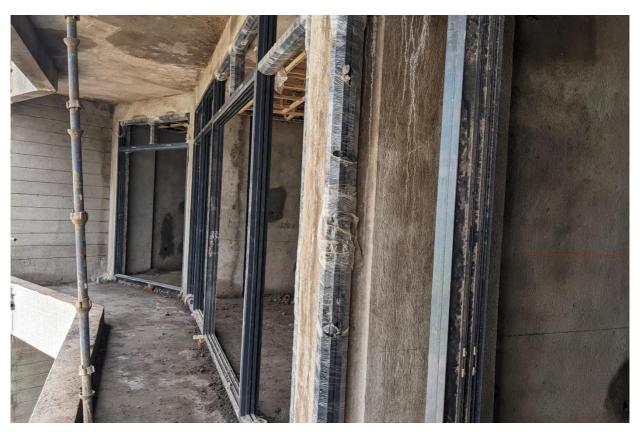
Phase 2 works showing: Curtain wall installed in one of the units

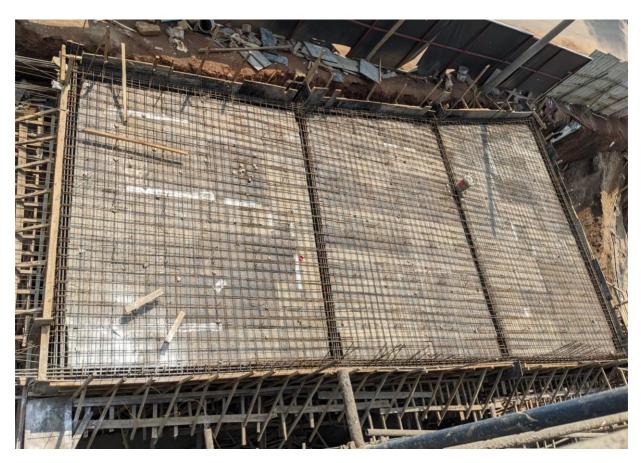
Phase 2 works showing: Steel reinforcement for drop-off slab

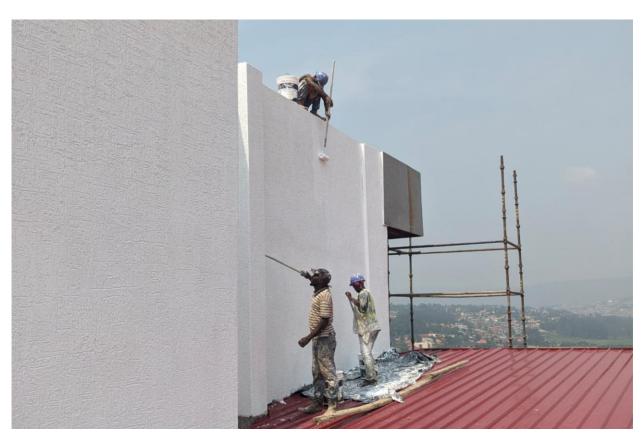
Phase 2 works showing: External paintwork at roof level
